Diagnostics of a hydraulic turbine failure

Abstract – This paper presents the failure analysis and diagnostic of a hydraulic turbine. Shortly after a maintenance revision the thrust bearing of the turbine was destroyed when the turbine was put into operation. The damaged bearing was examined and the possible causes discussed. To identify the problem that led to the failure of the thrust bearing, a comprehensive on-site measurement campaign was done. Vibrations, pressures, temperatures and operating parameters were acquired at different operating conditions of the turbine. The analysis of the data allowed to determine the source of the problem and to implement a solution.

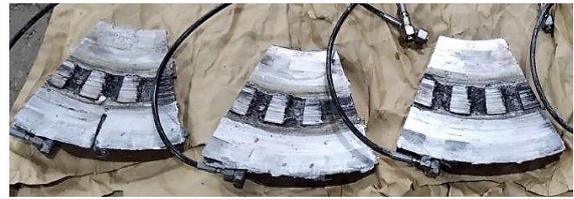
After starting the unit and before reaching full power, a temperature alarm was triggered. The metal temperature of the thrust bearing overpassed the maximum value and the machine tripped. The thrust bearing was dismantled and upon inspection a huge damage was revealed; the Babbitt layer of the pads (soft material which is generally an alloy of tin and lead) was completely erased and the rotating disk had several scratches. Figure 2 shows a drawing of the thrust bearing and Figure 3 a picture of the dismantled thrust bearing pads with the remaining material scratched.

Fig. 3. Bearing pads with damage

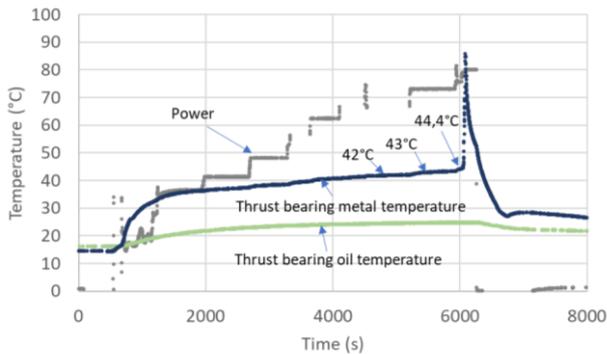
In Figure 5, the evolution of the thrust bearing temperatures has been represented. When increasing power, the oil and metal temperatures increase slowly at first but when power reaches 80% the metal temperature jumps in a few seconds from 44,4 °C to almost 90 °C. Fortunately, hydrostatic lubrication was provided at the right time and the machine was stopped.

Fig. 5. Temperature evolution with power

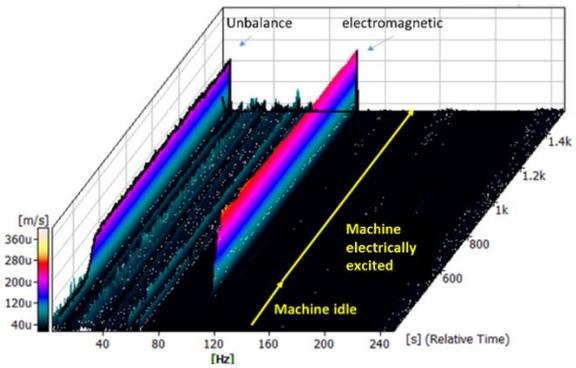
In Figure 6 and 7, the spectral cascades during the start-up process have been represented. In the first part of the transient the machine is not excited electrically so the electromagnetic forces do not appear. The only excitation forces affecting the machine are of mechanical and hydraulic origin. When the generator is excited, an important increase in amplitude at the rotating frequency (8,4 Hz) and at twice the line frequency (100 Hz) occurs. This means that the generator is not working properly, and it produces an electromagnetic unbalance. The unbalance also enhances the axial vibration at the misalignment frequency (2x rotating speed). The predominant vibration symptoms in the selected vibration locations were related to damage produced by the generator.

Fig. 6. Generator vibration during start-up and grid connection

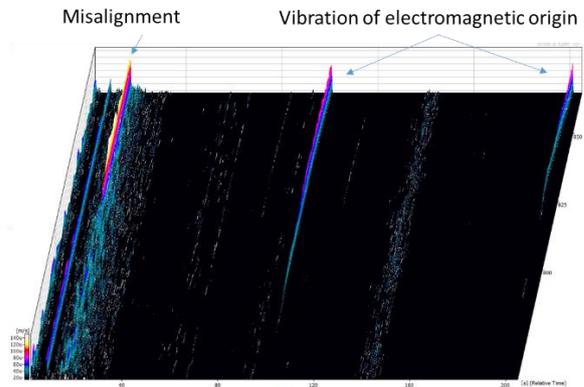
Fig. 7. Axial vibration in thrust bearing during start-up and grid connection

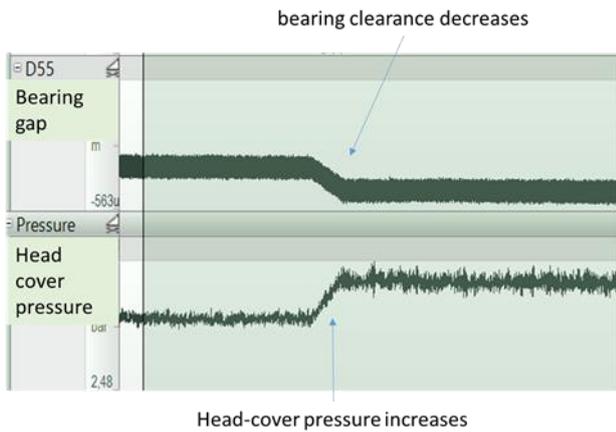
To check the axial thrust, the pressure in the head cover was compared with the axial displacement of the shaft. In Figure 8, the variation of axial displacement and head cover pressure with load can be observed. It is seen that every time the power increases the pressure in the head cover also goes up. This leads to the runner having a larger pull-down force, which results in the clearance between the rotating and the stationary part of the thrust bearing being reduced. In the turbine studied, every increase in pressure produced an increase in the axial thrust that was leading to an excessive reduction of the bearing clearance.

Fig. 8. Change in bearing clearance with water pressure when power changes from 1 MW to 2 MW

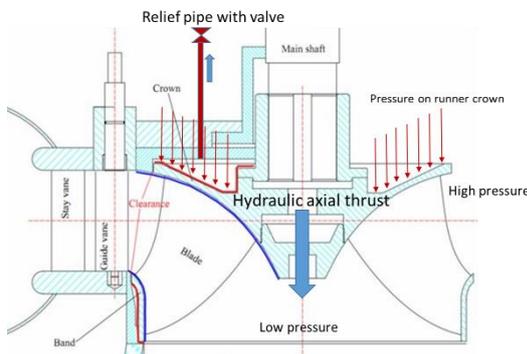
Fig. 9. Hydraulic axial thrust

In Figure 9, there is a schematic explanation of the axial thrust. The pressure acting on the runner crown is transmitted from the runner entrance (high pressure). On the opposite side of the runner the pressure is lower. This difference in pressure acts on the runner and produces a down-pull.

What was considered more important was the increase in the hydraulic axial thrust of the turbine with power. This axial thrust produces a down-pull that has to be supported by the thrust bearing. A significant increase in axial thrust was detected when increasing power, which can be due to worn runner seals not able to sufficiently reduce the pressure on the head cover. At a certain power the axial thrust was excessive, which resulted in a large reduction of the bearing clearance. The combined effect coming from an excessive axial thrust and a large axial and radial vibration produced by the faulty generator caused the oil film rupture.

To allow the electric company to operate the turbine until an overhaul of the whole unit was possible, a mitigation method was provided. To reduce the axial thrust, a relief pipe with a valve was installed in the head cover (Fig. 9). By opening the valve, the head cover pressure (and thrust) could be controlled. The optimum pressure was obtained with the tests and the further cases of damage were prevented.
