From causes to effects. Integration of heterogeneous data from non-invasive imaging for the diagnosis and restoration of monuments. The case of the Church of S. Francesco della Scarpa in Lecce (Southern Italy)

Giovanni Leucci¹, Francesco Gabellone³, Fabrizio Terenzio Gizzi², Nicola Masini²

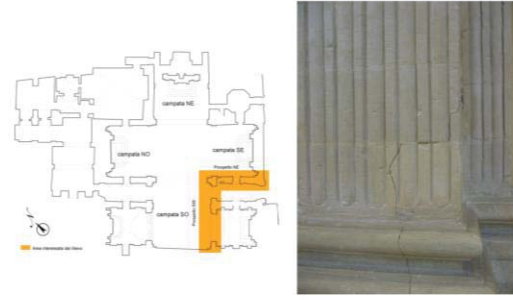
Figure 2. The area interested by structural problems

Between the years 2000 and 2005, the church underwent restoration interventions on both structural and historical-artistic aspects. After a few years some problems of structural degradation have arisen, consisting of a widespread crack pattern on a load-bearing element placed at the intersection of the SO and SE arms of the Greek cross. The cracks that are found are 0.5-3.5 mm wide, mainly vertical and sub-vertical direction and 10-30 cm long which affect the base and the stone cladding of the pillar (Fig. 2).

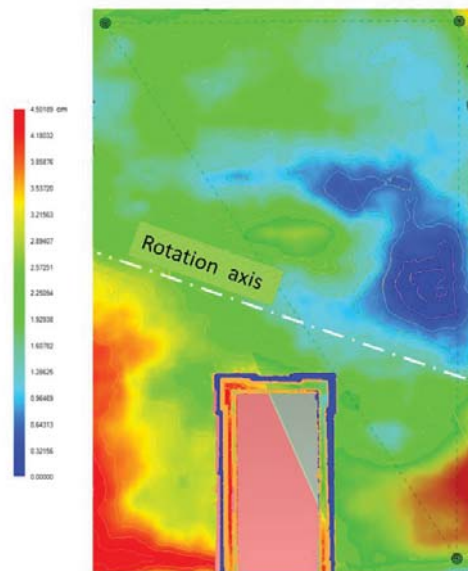
Figure 3. Deformation map obtained by laser scanner

The laser scanner survey revealed some constructional defects and out of plane deformations with a maximum value of 4.5 cm / 8 m (fig. 3).

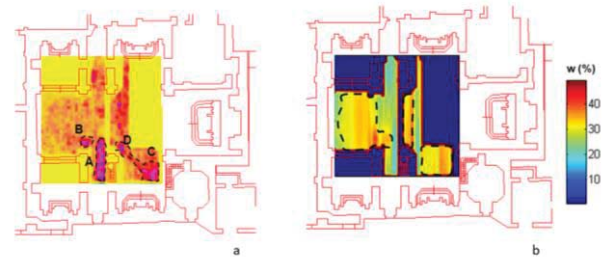
Figure 4 a) depth slice; b) volumetric water content map

From about 1.4m to over 2m radar profiles and time slices image the presence of cavities (fig. 4a), some of them close to the structure affected by instability phenomena. In correspondence with these cavities, the distribution of the volumetric content in water variable from 30 to 40% in the subsoil was estimated (fig. 4b). Seismic tomography prospections, applied to the structures revealed the distribution of the seismic velocity and allow to evidence the presence of weakened points. In the same structures, vertical seismic refraction tomography (fig. 5) detects very low speed values ($800 < V_p < 950$ m / s) for thicknesses ranging from 25 to 40 cm. This suggests that the lesions, although characterized by small amplitudes, are not superficial but affect the entire coating and probably the interface between the coating and the bearing core of the pillar.

The presence near the pillar of cavities, of which a small part was known and in the remaining part was detected by the georadar (figure 4, in particular see anomalies A and D) may have played a decisive role in: i) reversing the behavior dynamic of the masonry structure, ii) and determining the anomalous distribution of the P waves in the foundation. Both i) and ii) caused the instability phenomenon which manifested with the above described cracking pictures of the pillar, placed at the intersection between the SE and SO arms of the Greek cross plant. As a whole, the integrated and multi sensor approach (see fig. 8) proved to be effective in characterizing the effects and determining the causes of the instability phenomenon of the church.

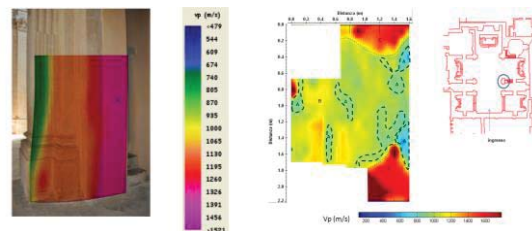
Figure 5. Seismic tomography results

In relation to the results of the relevant campaigns carried out, it is possible to establish that the crack pattern mainly affects the pillar coating but also begins to extend towards the bearing core.

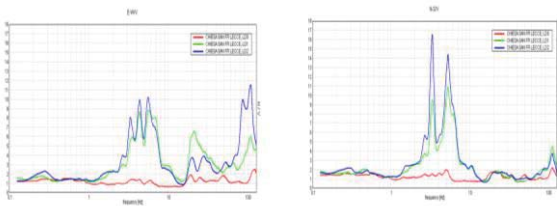
In particular, the analysis of the microtremor measurements (fig. 6) in the structure under investigation (NE facade of the SE arm) shows an inverse dynamic behavior compared to what is typically found on a wall. In particular, the mid-basal part oscillates more than the high part and with lower frequencies as well as having strongly different behaviors both in terms of frequencies and in terms of the extent of the oscillations if we consider the direction in the plane of the wall in comparison with the direction orthogonal to the plan.

Figure 5 - Northwest span: value of H/V in the two directions at the various altitudes (direction orthogonal to the plane of the masonry, also called direction E-W, at the top, and in the plane (N-S) in the plane, or direction E-W, at the bottom)

The anomaly in the dynamic behavior detected in the wall of the south east arm can be due to two possible causes: i) one is the presence of the rampart staircase which causes a drastic decrease in stiffness in the middle-basal part of the wall, ii) the second is a non-uniform soil-structure interaction, as is observed by 3d seismic tomography (fig. 7) which highlights a non-homogeneous distribution of the propagation velocities of the P waves.

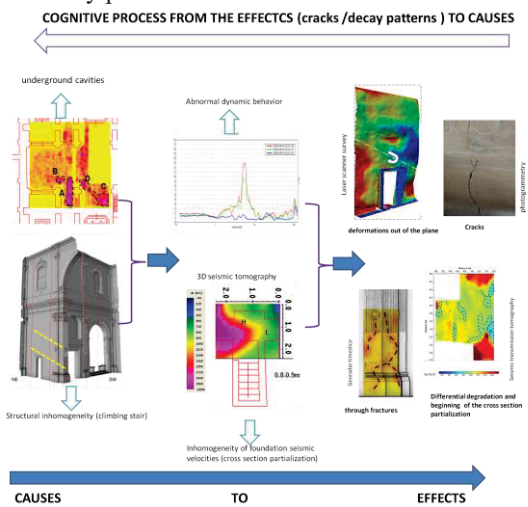
Figure 8. Schematic reconstruction of the results

In the current state of knowledge, the anomaly in the dynamic behavior detected in the wall of the SE arm can be traced back to two possible causes: one is the presence of the climbing ladder which causes a drastic decrease in stiffness in the middle-basal part of the wall, the second is uneven soil-structure interaction.
