Geotechnical investigation and field performance of a zoned earth dam in Italy

Abstract – The Farneto del Principe dam in southern Italy is a critical infrastructure, equipped with a complete monitoring system. Over the years, the effectiveness of this system has been drastically reduced, mainly due to a consistent number of malfunctioned piezometers. A substantial geotechnical investigation campaign was performed in 2015, and new piezometers installed. They are beneficial for supplementing monitoring data and enhance the reliability of the old monitoring system.

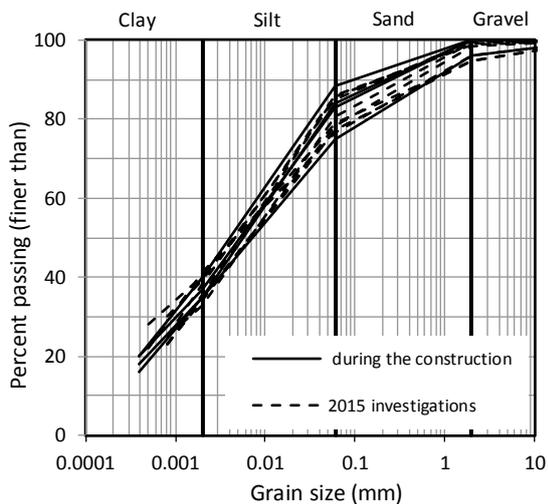
Fig.3. Grain size distribution curves for the dam core

Sieve and sedimentation analyses were recently performed on samples from the dam core [6]. Figure 3 shows the comparison between the grain size distribution curves from the 2015 investigations and those obtained during the construction of the dam. It can be noted that the curves are practically identical, thus that the groundwater flow within the dam body did not alter the core particle size distribution. This result suggests that neither internal erosion, nor migration of soil particles took place.

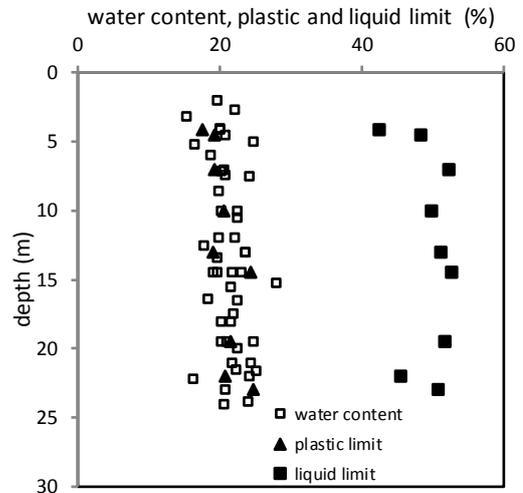
Fig.4. Water content, plastic limit and liquid limit versus depth

Laboratory index tests were also performed. Figure 4 shows the trend of the water content with the depth in the central core. The water content has a mean value of 20.5%. This value is slightly higher than the mean water content measured during the construction of the dam (17.88%). Figure 4 also shows the trend of the plastic and liquid limit in the dam core. This plot provides also a visualization of the trend of the plasticity index with depth. It assumes values ranging from 24.7% to 32%, with a mean value equal to 28.56%. The mean value of the plastic limit is equal to 20.8%, similar to the value measured during the construction phase, equal to 19.18%. The mean values of liquid limit are 49.36% and 45.4%, as measured during the 2015 campaign and the construction phase, respectively. Figure 4 shows that the natural water content is close to the plastic limit. Accordingly, the core material at the natural moisture content, assumes a

behavior between the semi-solid and plastic states.

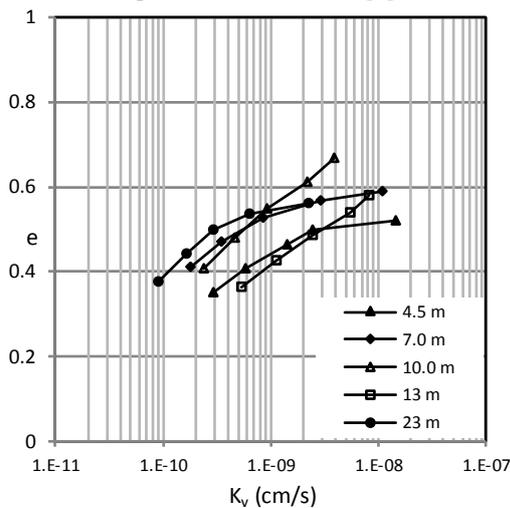
Fig.5. k_v against void ratio for various depths

The likelihood of failure in an embankment dam depends on the degree of control over internal erosion and piping in the dam body. These phenomena can induce an increase in permeability, and thus an increase in seepage, over time. Accordingly, the possible variation of the permeability is a critical factor for the stability of the dam. The scope of this section is to analyze the hydraulic conductivity measurement performed on undisturbed samples of the core materials, during the recent geotechnical investigation campaign. We measured the vertical coefficient of hydraulic conductivity (k_v) by means of oedometer tests. Test results show that k_v values fall within the range of acceptability defined during the construction of the dam. Figure 5 shows vertical hydraulic conductivity versus void ratio, at different depths. It can be noted that k_v increases with void ratio. Figure 6 shows vertical hydraulic conductivity values with depth. The two curves refer to two different vertical effective stress levels used in the oedometer tests, a lower bound ($\sigma'_v = 196$ kPa) and an upper bound characterized by $\sigma'_v = 3138$ kPa. As expected, the vertical hydraulic conductivity decreases with increasing depth. We performed additional measurement of the coefficient of hydraulic conductivity, by means of a falling head test carried out in the oedometer cell for two selected depths (4.0 m and 10 m). The results of these tests show that the vertical hydraulic conductivity values, estimated using the falling head tests (open triangles in Figure 6), are consistent with those obtained by using the oedometer test at the same depths.

problems. In the core of the Farneto del Principe dam, the hydraulic conductivity did not increase over time, being the values obtained during the construction phase actually larger than those measured during the 2015 geotechnical investigation campaign. These results show a good performance of the hydraulic behavior of the core. Generally, the hydraulic conductivity measured in the core of an earth dam right after the compaction, all other things being equal, is expected to increase over time. It takes several months for the water, after the construction, to flow within the core; as a result, during this period, significant thixotropic effects can occur [7].

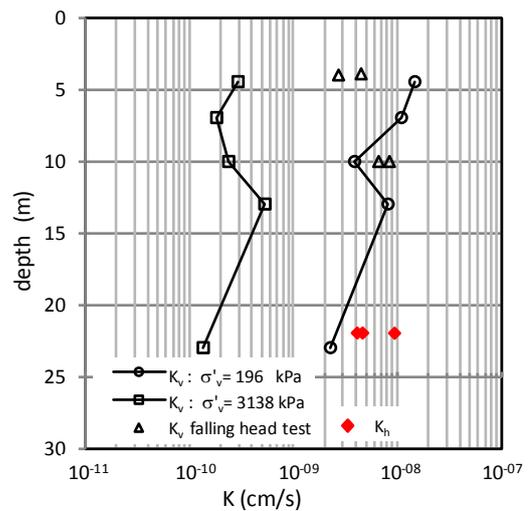
Fig.6. Hydraulic conductivity variation with depth

We also evaluated the influence of permeability anisotropy in the core, through the investigation of the coefficient of horizontal hydraulic conductivity (k_h), normal to the direction of compaction forces. Figure 6 shows k_h measured by using the falling head test in the oedometer cell, for various stress levels and for a sample taken at a depth of 22 m (red diamond). The horizontal hydraulic conductivity is slightly greater than k_v , providing a confirmation that the core material, compacted at the optimum water content, shows a partially-oriented structure, thus influenced by the water flow direction [7].

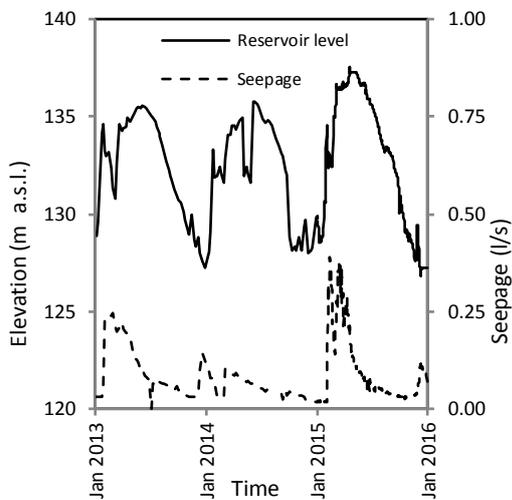
Fig. 7 Reservoir level and seepage flows in the period 2013-2015

The hydraulic performance of the dam can be assessed by measuring the seepage water collected, through a channeling and collection system, in the inspection tunnel, along the longitudinal axis of the dam. Inconsistency between measured seepage water and the reservoir level evolution can be related to a progressive reduction of the dam water-tightness [8]. Figure 7 shows values of discharge seepage water (i.e. drained water collected in the inspection tunnel) in the period January 2013 – December 2015. Ausilio et al. [4] show that, in

the previous period of observation 1991 – 2012, the maximum measured seepage was 0.53 l/s. The new data suggest the following important considerations: (1) the seepage values measured in the last three years are consistent with those collected in the past; (2) the seepage is hardly influenced by the water level in the reservoir, and (3) the seepage can be considered low enough to ensure stability to the embankment, because these values are relative to the whole dam, demonstrating its efficient water-tightness.

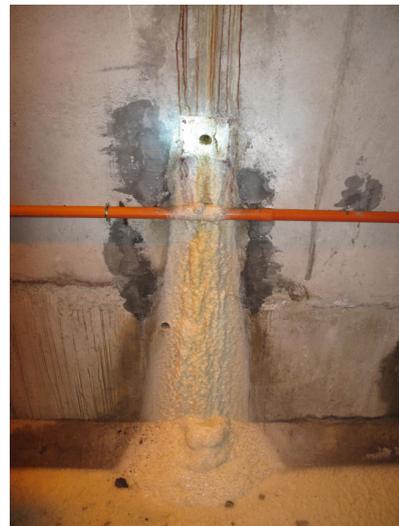
Previous studies show that chemical reactions (e.g. sulphide oxidation) can be detrimental for dam stability due to a possible reduction in the embankment shear strength parameters [9-11]. In order to evaluate whether the flowing water of the reservoir undergoes some chemical-physical change, a water sample taken in the reservoir and another one collected in the drainage tunnel were subjected to chemical-physical tests. Table 3 shows the results of these tests. The water in the tunnel presents higher values of conductivity, alkalinity, and magnesium ions. Furthermore, the water taken in the reservoir presents a larger quantity of calcium ions. This result is counterintuitive, but can be explained because calcium ions precipitate, forming calcium formations (stalactites) that are visible in the inspection tunnel (Figure 8).

Fig.8. Photo of the calcium formations present in the inspection tunnel of the Farneto del Principe dam
