Further Investigations on Limestone Artifact Surface Modifications by Laser-Induced Breakdown Spectroscopy Depth-Profiling

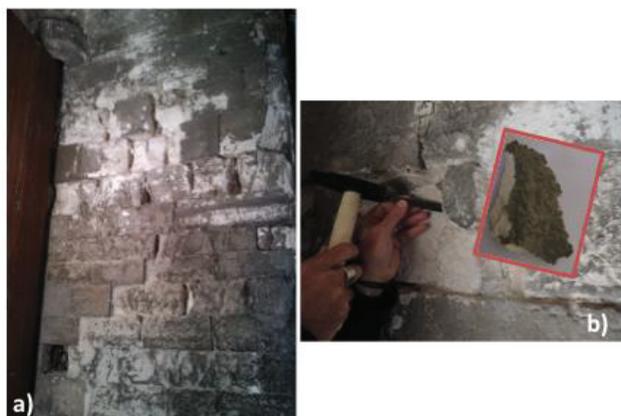
Fig. 1. The masonry limestone blocks of the jamb of the entrance gate of Castello Svevo (a) and area sampled (b). The red box inset shows the sample considered for the study.

The sample was collected from a selected block of the limestone masonry of Castello Svevo, Bari, Italy (Fig. 1), which is an historic multilayered monument built originally by Roger the Norman in 1131 on the remains of a Byzantine structure. The sample showed a surface degradation featured by a layer of black crust.

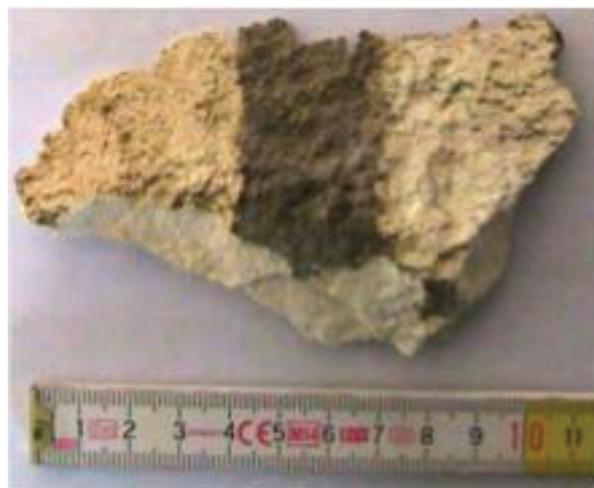
Fig. 4. The sample after laser cleaning using different wavelengths: 1064 nm (left zone) and first 1064 nm and then 532 nm (right zone). The centered zone is covered by the original black crust.

Two different procedures were applied to remove the black encrustations from the limestone [9]. The sample surface was divided into three areas that were subjected to different laser treatments. The first test was performed at the wavelength of 1064 nm (Fig. 4, left zone), and a second one by applying two consecutive wavelengths, the first at 1064 nm and the second at 532 nm (Fig. 4, right zone). The two tests showed a different level of cleaning with a better whitening effect when two consecutive laser wavelengths were used. The Nd:YAG laser provides pulses of typically few ns at the 1064 nm wavelength, which are preferentially absorbed by the stone soiled layers, thus producing a rapid increase of surface temperature and vaporization of the black crust. A further irradiation with the second laser harmonic (532 nm) of the areas previously cleaned with the fundamental wavelength resulted in a more complete removal of dust particles.
