Study of stability of Roman Bath, in Sagalassos (Turkey)

Abstract – Results related to integrated virtual archaeology and geophysical surveys at the archaeological site of Sagalassos (Turkey) were presented. Data analysis demonstrate the conservation state of the Roman Bath and suggest the restoration interventions.

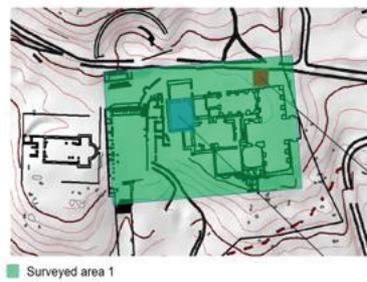
a

With the aim investigate the integrity of the Roman Bath structure, the ERT survey was conducted in an area 78 m x 127 m (Fig. 1a). A syscal kid switch with 24 active

Fig. 1. a) ERT Profiles; b) 3D electrical resistivity distribution in the subsoil; c) 3D iso - resistivity volume

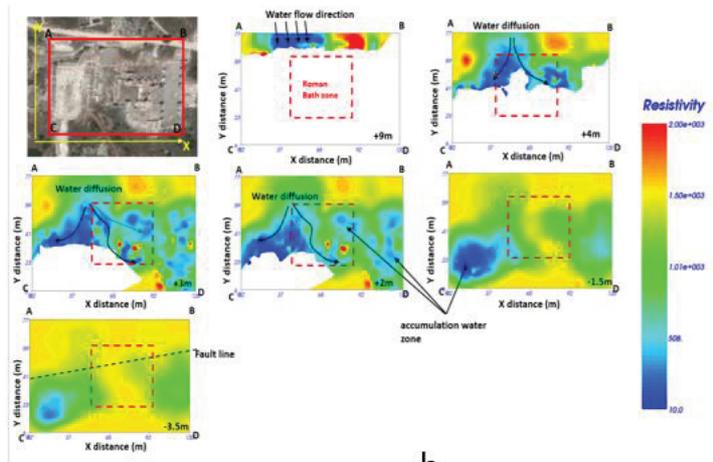
b

channels georesistivity-meter was used. The ErtLab software was used for 3D resistivity inversion [1] and a matlab code was used for 3D self potential inversion [2]. Fig. 1b shows the electrical resistivity model at six different depths. It is possible to note a low resistivity zone (10-60 ohm m) probably linked to the presence of a flow of water coming from the north. Part of water flow is directed towards the thermal baths and it spreads within them. It is possible also to evidence the fault line that crosses the baths. The 3D images of electrical resistivity can easily be visualized by 3D contouring of iso-resistivity volumes (Fig. 1c).

A low resistivity zone (10-60 ohm m) indicate probable water flow coming from the north. Due to the collapsed ancient drainage system the water path is random and therefore the water diffuses randomly along paths that for

centuries was opened in the building. Other high resistivity zones (labelled "C") are visible on the roof. These zones are probably related to a fractures system. It is possible also to evidence the fault line that crosses the baths.

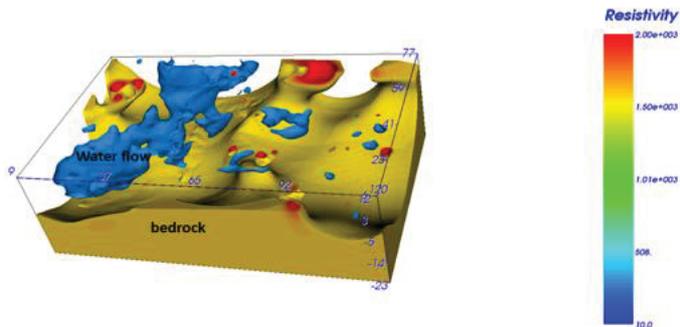
c

In Fig. 1c, the ρ data set is displayed with iso- ρ volumes using two threshold values ranging respectively from 1500 to 2000 ohm m and from 10 to 60 ohm m. This kind of visualization allows to emphasize both the bedrock variation depth (ranging from about 5m to about 12m in depth) and the water flow. In order to better understand the stability condition of Roman Bath the area 1 was subdivided in two sub areas labeled respectively zone 1 and zone 2 (Fig. 2a). Fig. 2b shows the electrical resistivity model at eight different depths. It is possible to note the probable ancient drainage system in the first slices (+9m) posed at about 3m in depth (referring to the current living surface). It is characterized by an high resistivity values ranging from about 4000 ohm m to about 5000 ohm m. These values suggest that the system empty and partially collapsed.

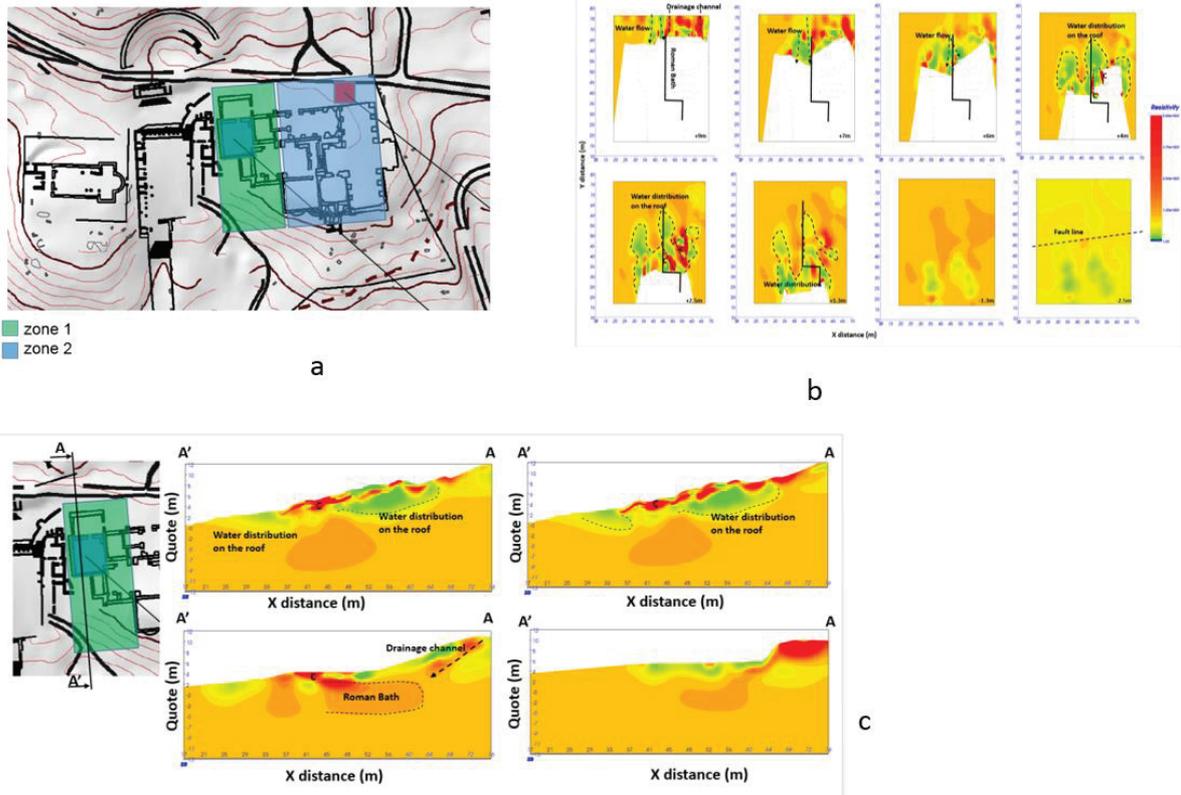
In order to better understand the distribution of the water on the roof a vertical distributions of resistivity are shows in Fig. 2c. Fig. 2c shows the electrical resistivity model at four different vertical sections that crossing the Roman Bath structure. It is possible to note the probable ancient drainage system. It is characterized by an high resistivity values ranging from about 4000 ohm m to about 5000 ohm m. These values suggest that the system empty and partially collapsed.

A low resistivity zone (10-60 ohm m) indicate probable water distribution on the roof. Other high resistivity zones (labelled "C") are visible on the roof. These zones are probably related to a fractures system.

Fig. 1. a) ERT surveyed areas; b) 3D electrical resistivity distribution in the subsoil; c) 3D electrical resistivity distribution crossing the roman bath

In the area 1 results indicates the problematic that affect the structure of Roman Bath. First one there is an uncontrolled water flow from the north hits the wall structure of the baths. ERT results show zones on the vault where the water stagnates. In these zones, the stability analysis showed a probability of collapse that could occur within 2 years.

Given the low values of the self potentials, the water flow velocity is fairly reduced. The flow velocity likely increases during the rainy season thus increasing the danger of collapse. Another problem linked to the

presence of water is related to the formation of ice during the winter. In the zones of water stagnation, this phenomenon leads to an increase in the volume of water and consequently to an increase of the probability of collapse.
