# Geophysical investigations on hypogeic monuments. The case study of the Crypt of St. Sebastian in Sternatia (Lecce – Southern Italy).

In this paper, GPR data gathered by the non-destructive investigation campaign, performed by means of geophysical surveys carried out on the vault and the inner pillar of the Crypt of San Sebastiano are shown. The study is part of a wide preliminary diagnostic campaign aimed at the restoration of the monument, which included a thermographic relief on the painted walls and on the vault, a monitoring of climatic parameters such as temperature and relative humidity of the air and of the wall surfaces. In addition, in order to identify the materials constituting the wall paintings and their alteration products, a complex microdestructive diagnostic plane were also performed on micro samples taken from . The gathered GPR data allowed us to identify the anomalies of the calcarenitic mass in order to highlight structural problems that could affect the stability of the monument. To this regard, a different behavior, in terms of homogeneity, alteration and microfracturing of rocky mass has been highlighted for the vault and the pillar of the crypt.

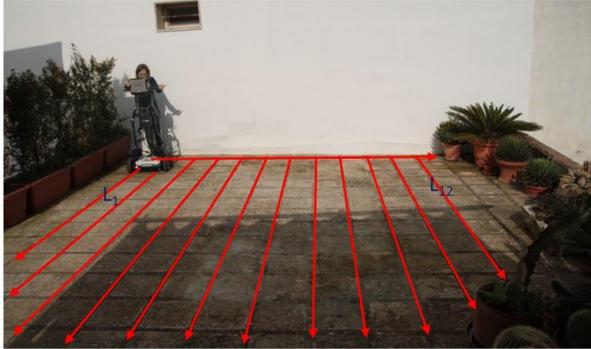
Fig 3a. First GPR prospection scheme on the vault

Geophysical survey was undertaken in five areas using Ground-penetrating Radar (GPR) technique. A Ris Hi mod georadar system with a dual band 600MHz-200MHz antennae was used. The GPR data have been gathered with a transect of 0.5m between any two adjacent measurement line, and the data have been processed by making use of the GPRSLICE code [1]. Particularly, the processing has consisted in zero timing, background removal, gain variable vs. the depth and Kirchhoff migration [2]. The dielectric constant has been retrieved from the diffraction hyperbolas [2]. In particular, here we focus on the results obtained with the antenna at 600 MHz.

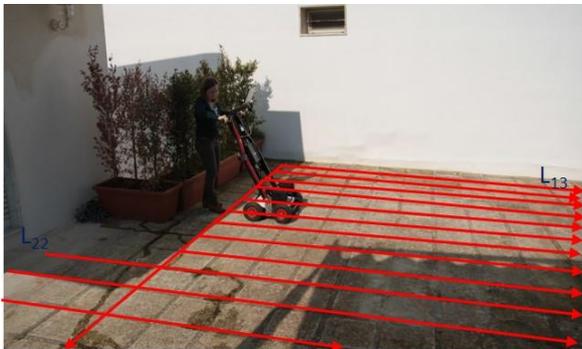
Fig. 3b. Second GPR prospection scheme on the vault

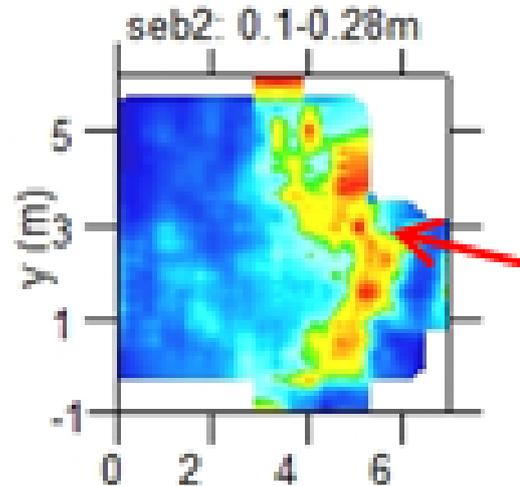
Observing the slices, it is possible to highlight that at few centimeters from planking level, namely in the slice between 0.1 and 0.28 cm (Fig. 4), an anomaly curved shaped is present. It could be related to the higher part of the ceiling of the crypt showing an irregular and different thickness of the as shown in the photo of figure 5, shot from the garden of the house located above the crypt.

Fig. 4. - Time slice 0.1 – 28 m depth

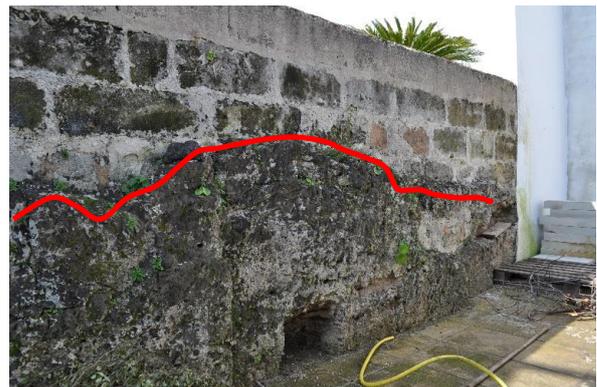
Fig. 5. View of the irregular thickness of the vault of the crypt.

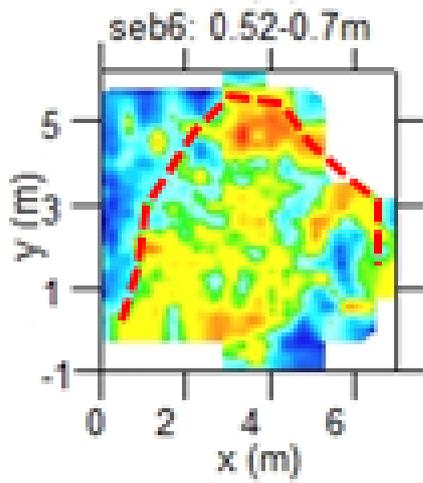
Moving in depth, the slices show the signals of rocky substrate of the crypt which increase up to the slice represented in Fig. 6. The strong signals recorded remark the interface of the ceiling of the vault that can be signed by the dashed red line (Fig. 6). In correspondence of the slice located to 0.84-1.02 m in depth, another regular and circular anomaly, marked by red circle, is present.

Fig. 6. Time slice 0.5 – 0.7 m depth

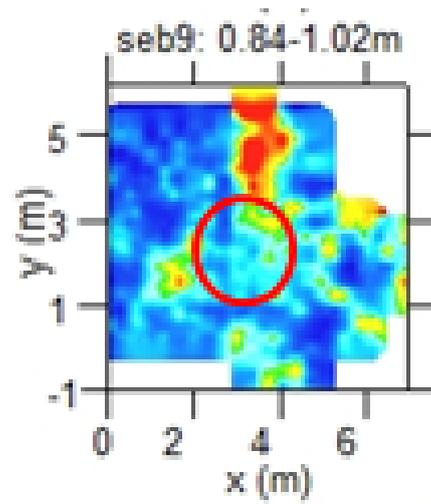
Fig. 7. – Time slice 0.8 – 1 m depth
