# Integrated approach for non-invasive diagnostic investigation at the Bishop's Palace of Frascati

**Abstract – Artistic surfaces at the Bishop's Palace of Frascati have been investigated by an integrated approach involving different non-invasive technologies. Information on previous restoration actions are reported in this paper.**

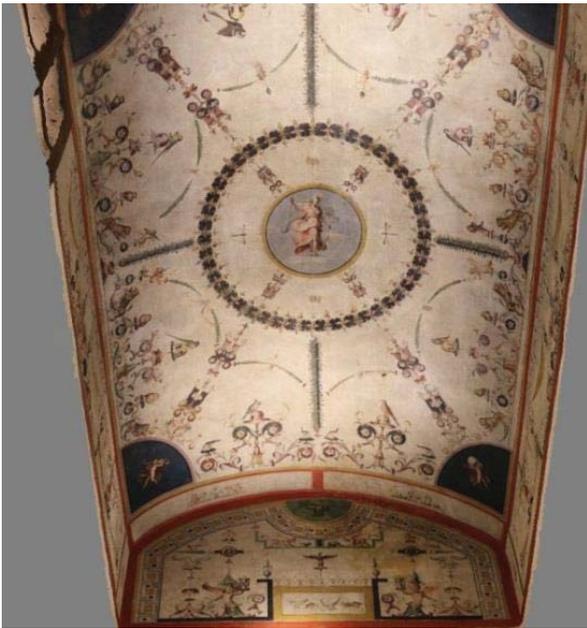
Fig. 3. 3D photogrammetric reconstruction of the stufetta tunnel vault.

More than one hundred 2D digital images of 8MB each, with zoom and focus held constant, were taken by the photogrammetric scanning in the stufetta tunnel vault. The post processing phase released a full 3D reconstruction as it is shown in Fig.3. The 3D real scaled model allows to focus some details to support and

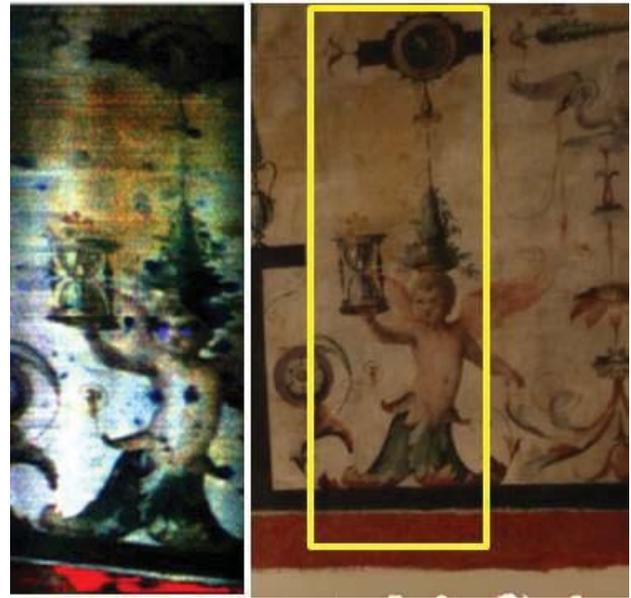
Fig.4. False colour LIF image, reconstructed at 300,400,500 nm, on the left; photogrammetric image with measured area in the yellow, on the right.

integrate the other NDTs measures and experimental results [18]. In Fig.4, the false colour LIF image, reconstructed at 300, 400 and 500 nm, is reported on the left. The relative photogrammetric image, with the measured area highlighted in the yellow line, is reported as reference on the right. As can be observed, some details not appreciable by naked eye have been put in evidence. In particular, the presence of a different material has been revealed in correspondence with the eyes of the angel, in blue in the LIF false colour image. By analysing the LIF spectra resulting from these points, it can be observed a narrow intense emission band at 380 nm (Fig.5, lower spectrum), ascribable to the presence of restoration materials probably containing zinc oxide, as suggested by the database developed in laboratory for cultural heritage in similar experimental conditions. Also in the chest some details have been put in evidence by the fluorescence images, but the relative spectra are composed by different emission bands, making probable a different composed restoration material, with low concentration of zinc oxide, to be present. Such material has been found also in other parts of the analysed surface. The presence of bio-deterioration has been also detected by the measurements. A grid of cell size equal to 0.05 meter was defined in the lunette above the angel in the photogrammetric model to monitor the areas affected by humidity over time (Fig.6). LIF measurements allowed to detect the presence of bio-deterioration, not only in those areas where it is visible by naked eye, but also in some areas where it is not visible absolutely. LIF spectrum associated to such degradation is characterized by the emission band at 550 nm (Fig.5, upper spectrum) that

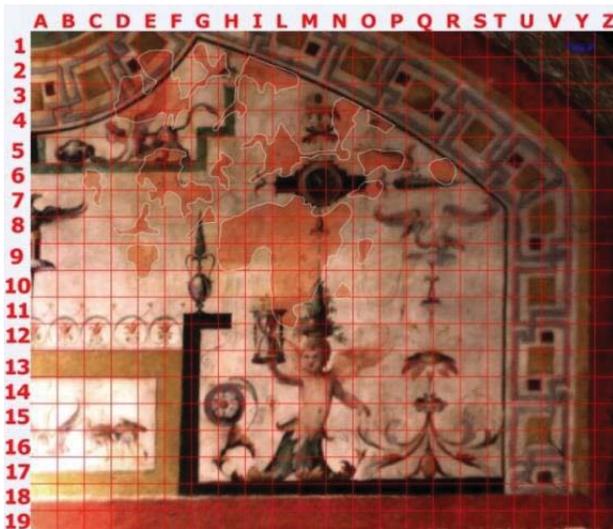
Fig.6. Photogrammetric real scaled 1:1 details of the lunette.

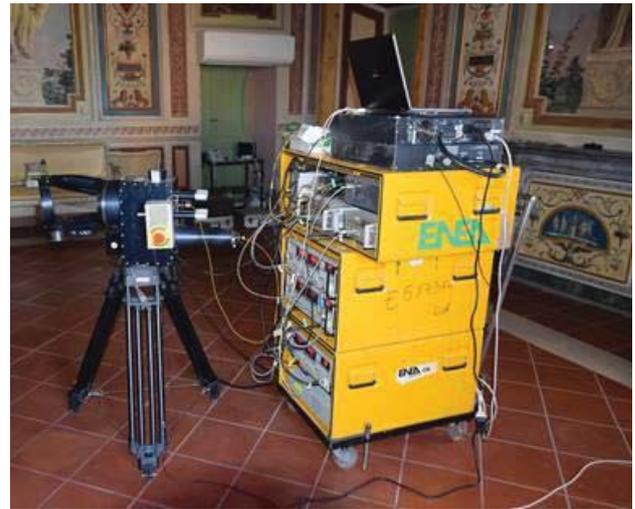
Fig.7. RGB-ITR operating in the Landscape Room.

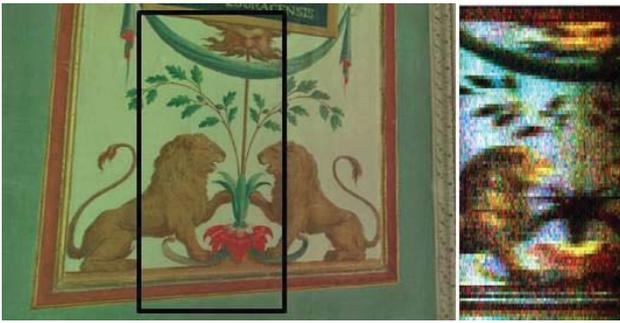
Fig.9. RGB-ITR image, with measured area in black, on the left; false colour LIF image, reconstructed at 300,400,500 nm, on the right.

collected spectra could be ascribed to cellulose, due to the substrate mainly composed of textile. In Fig.9, the false color LIF image of a detail on the painted left wall is shown next to the RGB-ITR image, as an example. Differently, by analyzing the painted wooden fire screen in the room, the LIF results highlighted the discontinuity of the surface materials. In Fig.10, beside the RGB-ITR image on the left, 380/450 nm fluorescence image of area, in the yellow line on the left side of the figure, is reported on the right. As can be observed, added materials, probably due to restoration actions and/or degradation processes, have been localized also in this case by LIF analysis even if they are not visible by naked eye in some points. Moreover, a post processing analysis of the RGB-ITR 3D models has been developed in order to carry out the circumscription of the areas of interest and to evaluate the eventual modifications respect to images collected in previous periods. The monitoring of the degradation processes could be provided in this way by repeating the measurements at different times.

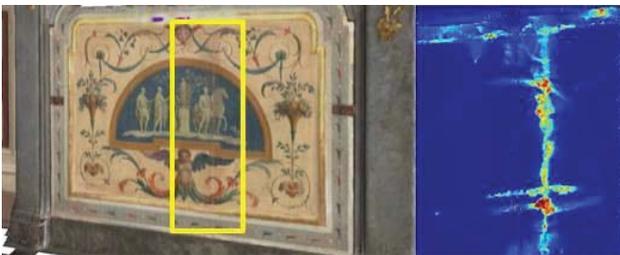
Fig.10. Fire screen RGB-ITR image (left); 380/450 nm LIF image of the analysed area, in the yellow line, (right).
