# Cultural Heritage and earthquake: the case study of San Francesco's church in Amandola (Central Italy)

**Keywords:** Masonry Church, FE Modelling, 3D Smeared Crack Model, Nonlinear Static Analysis, Earthquake Loading

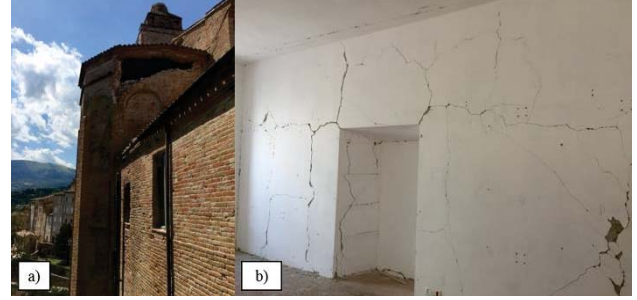
Fig. 3 External cracks on bell-tower and apse a), internal cracks on a wall of the cloister b)

The last central Italy earthquake hit the church, already after the first quakes of 24th August 2016 the church was closed. The church reported many damages, especially on the bell tower and on the lateral chapels. The bell tower lost the upper part of the pinnacle after the 24th August seismic shock. After the 30th October 2016 earthquake, the last section of the tower was damaged with shear cracks on the South wall. The chapels on the West side of the monastery show the activation of out of plane mechanisms. Also, the cloister was severely damaged by the quakes. The structure shows extensive damages on the brick cross vaults of the cloister and on the Southside. This building also shows shear cracks, and the activation of North façade overturn (FIG. 3).
