Mineralogical and chemical characterization of surface orange layers on the limestone of the Monastery of Batalha, Central Portugal

Abstract – Samples of orange surface patinas found on the limestone balustrade and sculptures of the Batalha Monastery in Portugal, have been investigated by X-ray micro-diffractometry (μ -XRD) and Low-Vacuum Scanning Electron Microscopy coupled with Energy Dispersive Spectrometry (LV-SEM + EDS). Aim of the study was to assess whether the orange layers have been intentionally applied or were resulting from stone weathering. Preliminary results suggest that the orange layer on the surface is mainly consisted of gypsum and hematite with halite and weddellite as minor components. This discovery implies the possibility that such orange patinas were applied intentionally instead of having been formed naturally by decay. A comparison was made between this patina and the “scialbatura”, a protective coating often applied by conservators on limestones and marbles in monuments.

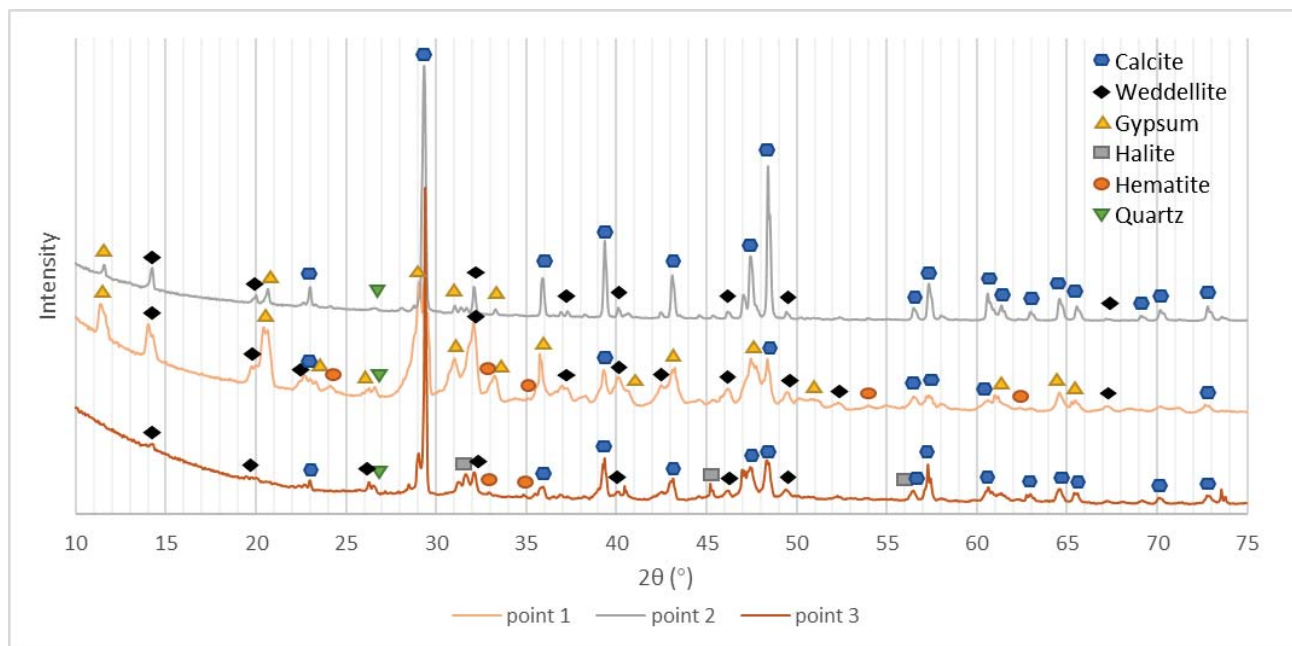
Fig. 6. XRD results on Royal Cloister balustrade.

Figure 5. shows the balustrade piece, this sample has no fallen fragments, thus it was examined only by XRD as a bulk in order not to cause any damage. Figure 6. shows the XRD pattern. In Table 2 the main minerals are listed together with their semi-quantitative evaluation. It is illustrated that, at point 1, where an orange surface is still visible, there is a high content of gypsum and weddellite with minor amount of hematite. At point 2, where the orange surface is worn-out and the white substrate appears, the main composition is calcite, and the contents of gypsum and weddellite show a significant decrease, also hematite was not detected. At point 3, there is some dark orange powdered deposition, which has a different appearance than point 1, the result shows a majority of calcite (limestone), some weddellite and

hematite, the presence of halite at point 3 is distinct from point 1 and point 2.
