Dynamic Identification of the Damage for a Parabolic Tuff Barrel Vault with Differential Settlements of the Supports

In this context, this paper studies the damage identification of a full-scale parabolic tuff barrel vault subjected to differential settlements of the supports starting from vibration measurements.

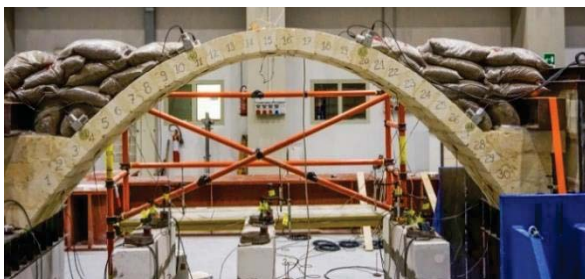
A suitable experimental setup has been designed, allowing for the control of the vertical settlement of one of the two supports of the vault. In particular, the two supports of the vault were made by steel beams: one fixed, while the other could be moved by a hydraulic jack, allowing for imposing vertical displacements of one of the abutments of the vault. Two additional steel beams placed on the top lateral shoulders of the vault gave further constraints, avoiding rigid rotations of the whole structure.

After the construction of the vault, 40 sandbags were placed on the shoulders of the vault in order to simulate the infill load (Fig. 3), with a total weight of 840 kg.

Fig. 3. Experimental setup.

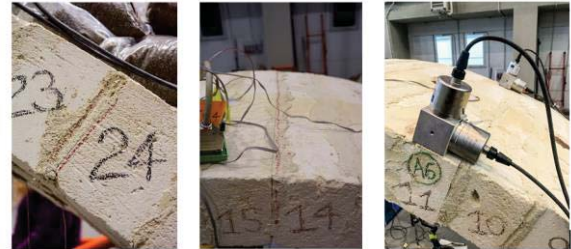
Fig. 4. The three crack hinges.

In particular, the cracking hinges due to the imposed differential settlements formed in positions compatible to those characterizing the collapse mechanism of a circular arch under vertical supports settlements without rotations of the abutments (the mechanism labeled “III” in [18]). In particular, an intrados cracking hinge formed in correspondence of the joint between voussoirs 23 and 24, and two extrados cracking hinges appeared in correspondence of the joint between voussoirs 14 and 15, and of voussoirs 11 and 10, respectively (Fig. 4).

The test was interrupted when cracks formed transforming the vault in a statically determined structure, thus capable of adapting to differential settlements of the

abutments by rigid body displacements. This happened at the 11th step, corresponding to about 17 mm of relative vertical displacement of the abutments.

According to the observations in [19], the slight differences from the cited mechanism in [18] are likely ascribable to the shape of the vault (that is parabolic rather than circular), by the different embrace angle and by the different thickness-to-radius ratio.
