Cognitive methodology and diagnostic plan for cultural heritage conservation.

Caterina Gattuso

The article proposes the results of a research aimed at supporting a conservation work and enhancement of a monumental cult building of the Byzantine era, the abbey of Santa Maria del Patire, located in the municipality of Rossano (CS - Italy) one of the most interesting Byzantine architectures in Calabria. The research started with a historical survey and an identification of the relevant components of the abbey. The heart of the research is the characterization of the church constitutive materials for conservative purposes, in a cultural perspective of prevention of potential degradation forms.

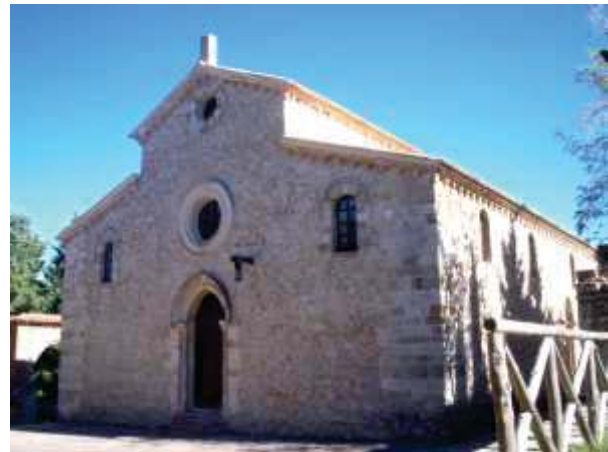
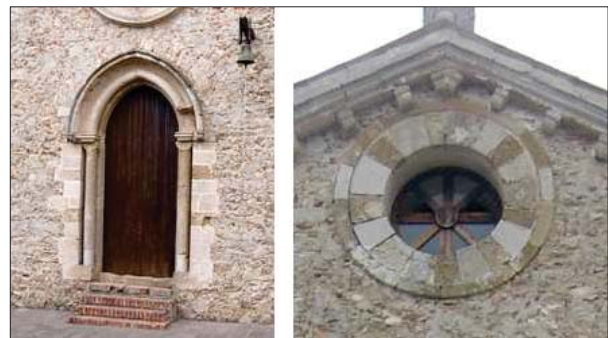
Fig. 2 - View of main church

provided by three major doors. Today there is just one. The rose window above the door is modern, the small one at the peak apex is ancient and it was built with white and yellow alternating stones. A stone portal emerges, with an ogival arch, supported by sandstone columns, with decorated capitals; two little windows in correspondence to the side aisles, complete the austerity of the church façades (Fig. 2).

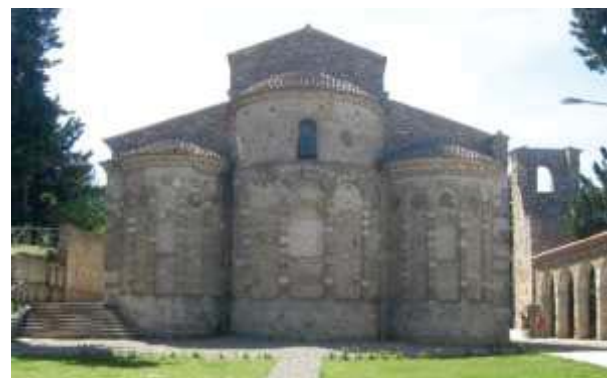
Fig. 3- Exterior apses of the church

The opposite side is characterised by three circular apses of Arab-Norman style, with plant to semicircle, the central one with ampler dimension compared to the others two as the aisles (fig.3). The apses are expression of chromatic taste exquisitely oriental decorations and even color are found in the lateral portals.

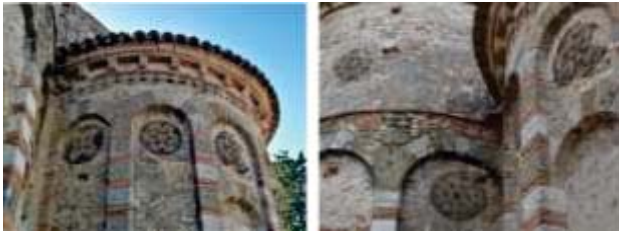
Fig. 4 - Apses details: pilasters and windows

A series of blind arches scanned at the rate of five by pilasters resting on high plinth, runs instead, the three apses and each arches is decorated, in turn, by a round that encloses a star pattern made with weave of various color

The effect is that of a lively and evocative polychrome lace [10, 11]. On every of the two side walls, in central position, a front door is situated. One of them, flanked two columns, has in summit a ferrule with an original arrow motive, while on the other one, also flanked by two columns with capitals and decorated shelves, take place an original decoration with stylized flowers (Figs. 4 and 5)

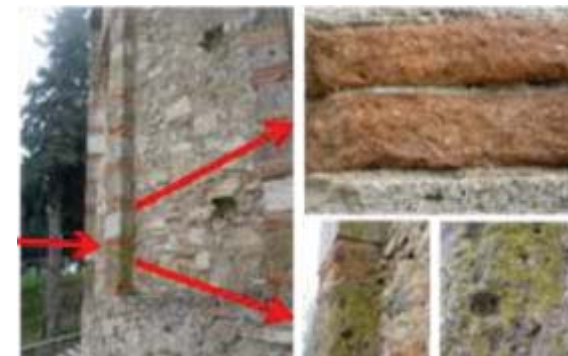
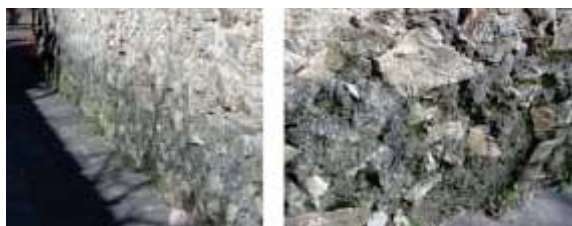
Fig. 9 - Façade

The superficial degradation due to the external agents that affects different parts of the surfaces appears in a diversified way (Fig.7-9); it can be clearly noticed the action of pulverizing of mortar joints, bricks breakups and infiltrations of rising damp [18]. bricks degenerative processes have led to a very unusual deterioration typology; they have allowed an erosion in such a way as to highlight tiny fragments of materials used in the construction phase. Other building surfaces, because of the presence of damp patches, are characterized by a widespread and specific bio-deterioration, related to the

activity of micro-organisms that has also led to slight and localized forms of alveolar erosion [19].

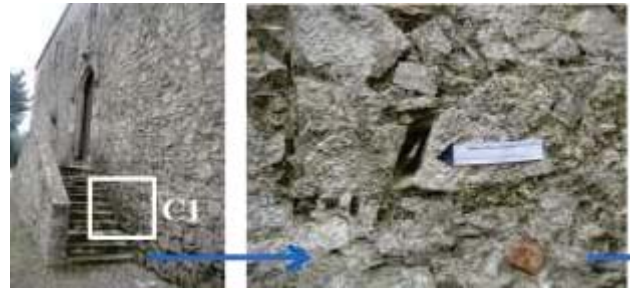
Fig 10

Patirion Church, some representative samples have been collected, avoiding to affect the integrity of the monument; they are part of already detached fragments of mortar and brick from the apse of the building and from a side wall. Figures 10 and 11 show the original position of two representative samples in the building and a photographic enlargement of the same samples (Fig. 10,11).
