High performance laser survey and 3D stress analysis for maintenance and preservation of artistic assets

Abstract – The research described in this paper shows the results of preliminary analyses carried out on an artwork housed in a museum complex. A three-dimensional model of the sculpture, resulting from a laser scanner survey, has been analysed to understand its current state and seismic response, from a quantitative and qualitative point of view. The results highlight the great advantages resulting from integration of traditional and novel procedures in the field of conservation of artistic assets.

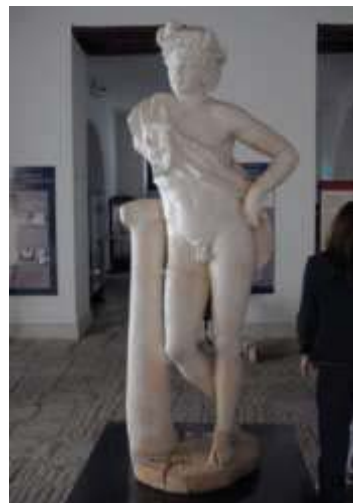
Fig. 1. The resting Satyr, Archaeological Museum of Ancient Capua (photo by authors).

The “resting Satyr” is a marble sculpture housed in the Archaeological Museum of Ancient Capua in the city of Santa Maria Capua Vetere, a town near Caserta. The artwork (Fig. 1) was discovered in the autumn of 2002 during the excavation activities of an ancient roman villa, a *domus* of imperial age [7].

The Satyr is one of the many replicas created in Adrian-Antonine age and some technical peculiarities allow the artwork to be dated to the first half of the II century A.D, a period of great artistic and building production for the ancient city of Capua. The Satyr is in a frontal position, standing on an oval base and resting against a tree trunk on the right. Such as for the other replicas, the Satyr has his head raised – slightly rotate to the right –, the right shoulder higher than the left and the right leg flexed, rotated outward and moved back to the left heel [7].

When the sculpture was discovered, it was fragmented and showed several ancient damages that were repaired. In particular, interventions were carried out “to connect the based cracked in two parts, the tree trunk to the body of the Satyr, the right leg with the left heel and, finally, the pine twig on the right side of the forehead” [7].

The connection between the several parts was made with iron bars, fixed with lead. These elements caused further damage to the artwork and in the recent restoration works, steel bars, insured with epoxy resin, were put in place to connect the many parts in which the sculpture was found, while the lacks were filled with plasterworks aesthetically balanced [7].

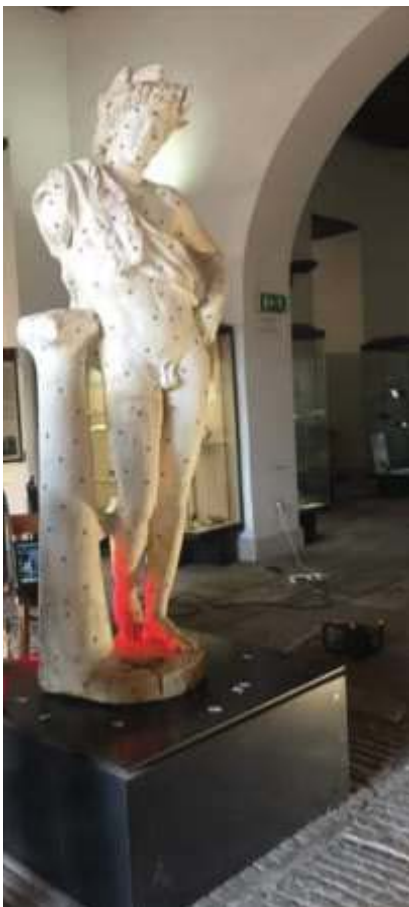
Fig. 2. Preliminary phase of scanning process (photo by authors).

At the same time, a metric survey has been implemented. The Satyr survey was carried out by HandyScan 700 laser scanner by Creaform [8]. It is a handy device that allows to acquire high quality data even in the presence of environmental variations. After the warm up operations, consisting in the scanner calibration and optimization of shutter and resolution values, about 353 circle markers were put on the statue in order to acquire a network of reference points selected depending on the global and local configuration of the surface (Fig.2).

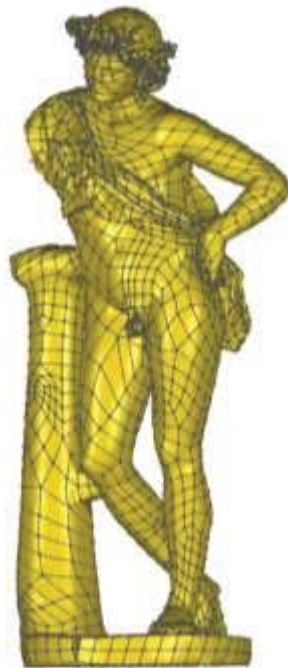
Fig. 5. Solid model of the resting Satyr (photo by authors).

During this scanning process an input filter was applied to data acquired through laser scanning. The final result of the mesh editing process is a mesh model characterized by about 400.000 triangular polygons, then best fitted by about 4.200 faces with higher density where more details occur (Fig. 5). This surface model can be managed better during the simulation phase, as all useful geometric details are kept causing a lower computational effort and shorter processing time.

The solid model is simplified from the point of view of material characteristics. Indeed, in the analysis have been not considered the integrations made with stucco during the last restoration and a homogeneous material has been considered. In Fusion 360 software by Autodesk, which integrates CAD and CAE solutions, on the 3D model imported via Step file two different structural analyses have been implemented, the static stress and the modal analysis.

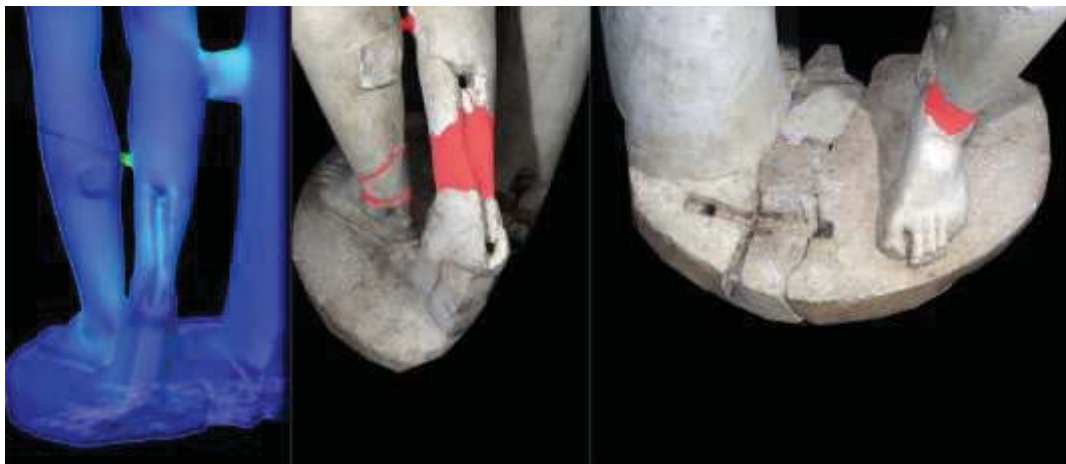
Fig. 7. Results of static stress analysis versus previous restoration works(photo by authors).

critical in bearing the loads and need to be further investigated. A detailed mechanical model can be certainly obtained based on the survey presented above, since the interfaces between old and restoration materials are clearly detected. An open issue still holds, since review of statue history confirms the presence of metal bars in the left leg, in the right leg to connect it with the heel, in the connection between the trunk and the right leg and, finally, in the connecting element between the two legs [7] (Fig. 7).
