Geomatics as a knowledge base propaedeutic to the restoration of an extended *fresco* wall

Gabriele Bitelli¹, Valentina Alena Girelli¹, Giulia Vannucci¹,
Emanuele Mandanici¹, Marinella Pigozzi²

Abstract – In the project, carried out by the Geomatics group of the DICAM Department from the University of Bologna, it is discussed the integration of different sensors as an application to the field of Cultural Heritage. The fresco painting examined dates back to the beginning of the XVII century, it is found in the San Martino theatre hall, in the city centre of Bologna. Terrestrial Laser Scanner (TLS), Photogrammetry and Thermal Analysis were employed as support for the analysis of the damaged fresco, and their integration, upon calibration, allowed to obtain a detailed representation and mapping of the fresco and its decay. In addition, it is now carried out a further research considering the role of Intensity of the TLS data, which could provide additional information about the conservation state of the painting's surface.

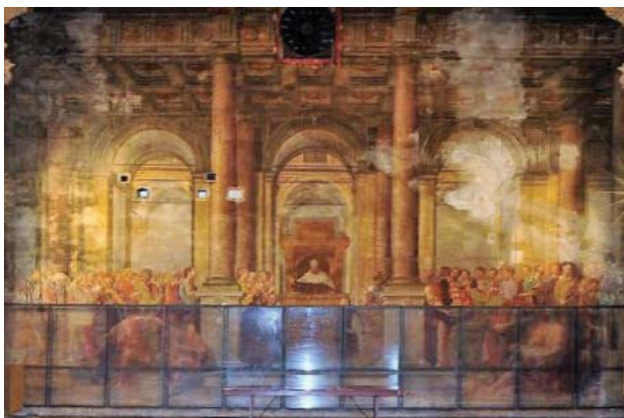
Fig. 1: The fresco by G. Massari and G. Curti (<http://www.centrosanmartino.it>)

The library of the Carmelite convent, which extends over the chapel which has long been used as a sacristy, was built between 1625-1629 by the architect Giovanni Battista Falcetti, repeatedly involved in contemporary city sites, both diocesan and religious. In the back wall there is the largest fresco in Bologna, measuring 104 square meters (13 × 8 m).

The hall where this fresco is found underwent many transformations during the centuries, adapting to different uses (library, cinema, theatre, university classroom and theatre again). After the second world war, when the space was turned into a cinema, some holes were drilled on top of the fresco for the projection, and the painting was covered by panels. All these interventions, together with seepages of acidic rainwater in correspondence to a

drainpipe, have severely damaged the valuable artwork, which now is seen in an unfortunate state of conservation. In particular, the infiltrated water from the top migrated through the wall, with consequent re-crystallization of the soluble salts during the evaporation phase.

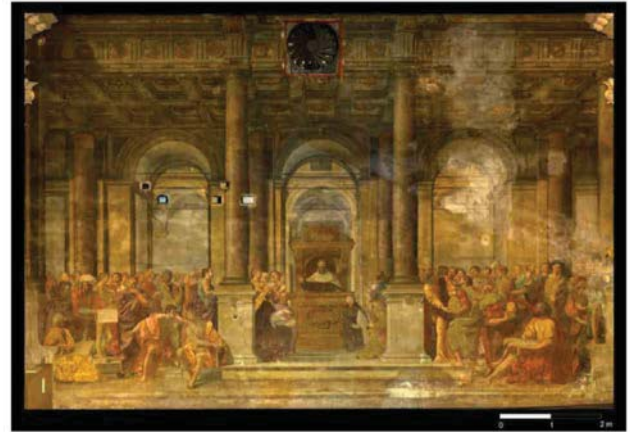
Fig. 7: Orthophoto of the fresco (original nominal scale 1:50, pixel resolution of 2 mm).

One of the products obtained by photogrammetry was the orthophoto shown in Figure 7, characterized by a nominal scale of 1:50 and a resolution of 2 mm.
