Geophysical investigations, digital reconstruction and numerical modeling at the Batia Church in Tortorici (Messina, Sicily): preliminary results

Abstract – The paper presents the results of scientific investigations carried out at the Batia Church located in the small village of Tortorici (Messina, Sicily). We performed several geophysical surveys and reconstruct 2D and 3D digital models of the monument. Finally, we present the structural analysis and numerical simulation with the aim of study and evaluate seismic vulnerability of the structure. The analysis consists in collecting data with noninvasive portable instruments to characterize local site effects as well as dynamic properties of the structure.

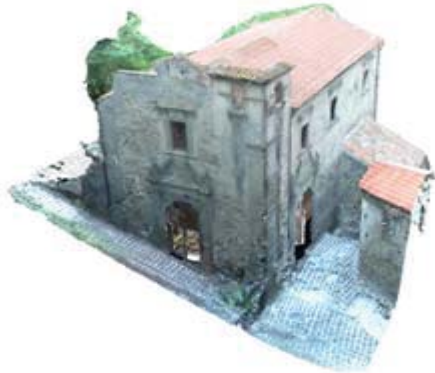
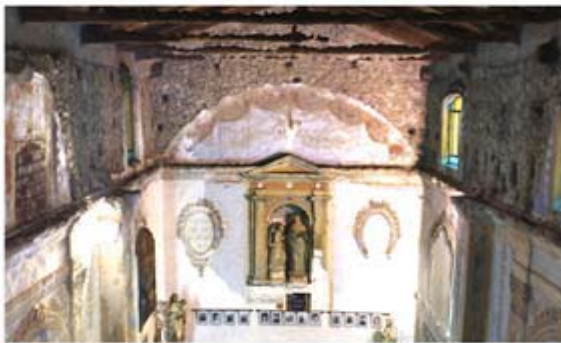
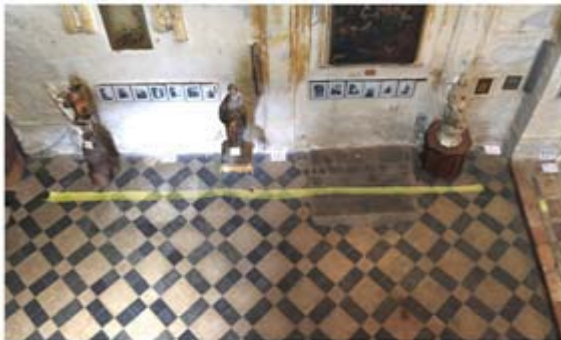
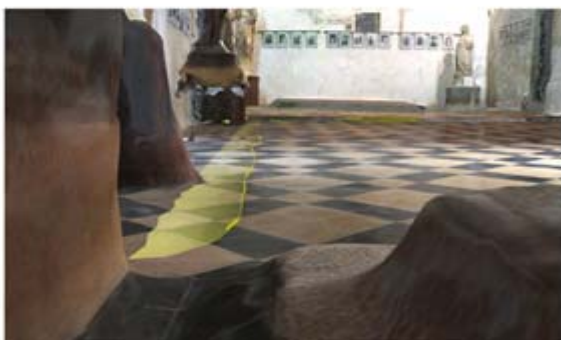
Fig. 3. High resolution photogrammetric model (internal and external) of the church of Batia. In the figures below the yellow areas represent the highlighted anomalies of the geophysical investigation.

Photogrammetry is a relatively new technique for accurate digital capture of 3-dimensional objects. The photogrammetric process consists of several phases of processing (see [4] for details). Various markers have been placed throughout the area of interest (mainly on the ground) and the relative spatial coordinates have been detected through accurate measurements. To create the model presented in Figure 3, approximately 1500 images were acquired during two separate campaigns. The images were collated at different distances about 70% overlap forward and 60% overlap sideways.

The development of the 3D model was carried out with free and open source licensed software such as VisualSFM, Meshlab and Blender. The final model (obtained by fusing the internal and external part) is perfectly scaled and measurable with a millimetric precision. Furthermore, the results of geophysical investigations have also been included in the digital model. The digital model has also been uploaded to a computer platform that can be consulted remotely and can be used for the enhancement of the artifact as well as for the creation of special content for documentary purposes.
