Innovative diagnostics through Hypercolorimetric Multispectral Imaging and Pulse-compression Thermography to support the restoration of a 16th wall painting in Palazzo Gallo (Bagnaia, Italy)

Abstract – This paper summarizes the main results of the study, restoration and diagnostics applied to the 16th century wall painting (a portion of the frieze and the Riario coat of arms) in Palazzo Gallo (Bagnaia, Viterbo – Central Italy) recently concluded and object of a master's degree work in Conservation and Restoration of Cultural Heritage. Innovative imaging techniques were used for the first time on a wall painting on-site: Hypercolorimetric Multispectral Imaging (HMI) and Pulse-compression Thermography (PuCT), combined with more traditional analysis. Multispectral imaging allowed for mapping the conservation status before and after the removal of the *scialbo* layer that covered the original paintings. It also allowed to compare between different areas of the painting and to verify the effectiveness of the cleaning. PuCT allowed to detect cracks and discontinuities in the ground layers and to evaluate the depth of such anomalies giving a valuable support in the consolidation step.

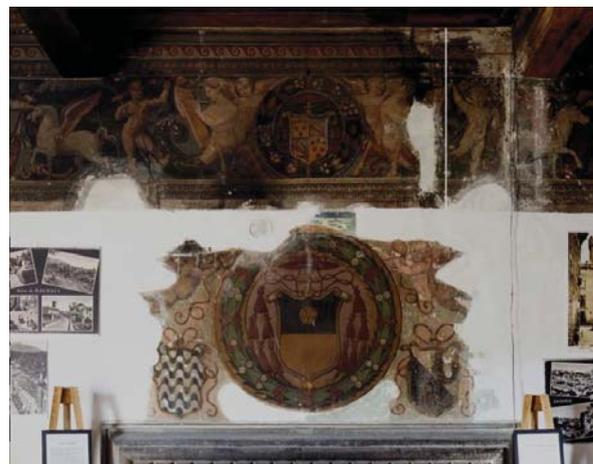
Fig. 1. The wall paintings before the restoration. Photo by Gaetano Alfano.

coat of arms of Bagnaia, just above the fireplace. The coats of arms are carried by putti through ribbons and the decoration in its simplicity is rich and varied. In 1576 Sulpizio Gallo, Giuliano's heir, sold the building to the Municipality "a complex of over twenty rooms (...) beautiful paintings in the reception rooms, a huge fireplace in the living room and a delightful porch on the square" [2, p. 61]. The importance of Bagnaia is given by the abundance and refinement of the artworks created there. After that date, there is not much information on the history of the Palace, but it is certain that the rooms were used as private residences for those displaced by the war since 1943 and consequently adapted by adding balconies, partitions, and installing an economic kitchen. Furthermore, during this period, many superimposed layers were added to cover the original paintings in the area above the fireplace more and more heavily to hide them largely. The antiquity of the Palace and its conservation events led to a serious situation of adhesion defects and deep cracks, provoking a deformation of the plaster in the upper right area, mainly due to the presence of the fireplace and the flue. In addition, the central part of the wall is made up of bricks arranged by cutting, otherwise the rest of the work is built on solid masonry in blocks made of *peperino*, the typical local stone of Viterbo. Finally, the use of the fireplace and the kitchen produced carbon black deposits on the painting surface which, together with an altered protective applied in the past, made it difficult to read the artwork, as visible in the image before the restoration activities started (Fig. 1).

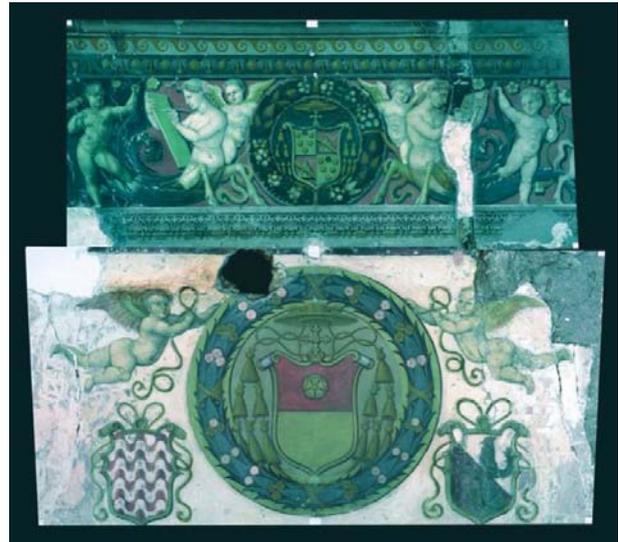
Fig. 5. IRFC images of the wall paintings after the almost-complete removal of *scialbo*, obtained with PickViewer®.

In the same stage of the restoration, HMI was also applied to investigate the material distribution, to map the *scialbo* layer still present on the surface and to check the effectiveness of the cleaning intervention. Specifically, this last aim was reached by applying the colour measurement algorithm of PickViewer® software to uncleaned and cleaned areas to compare the chromatic coordinates. PickViewer® was used for obtaining the infrared and ultraviolet false colour (IRFC and UVFC) images of the painting that allowed to hypothesize the composition of some pigments: blue smalt that appears vine colour in IRFC (Fig. 5), vermilion/cinnabar that becomes yellow and different greens (earths and Emerald green) that exhibited different response in false colours. All these pigments were confirmed by XRF spectroscopy that detected cobalt and arsenic for smalt, mercury for vermilion/cinnabar, iron for green earth and copper associated to arsenic for Emerald or Scheele's green (non-original pigment), (Table 1).

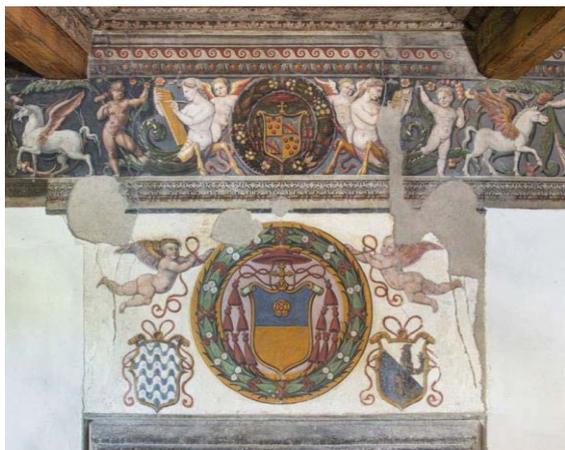
Fig. 11. The wall paintings after the restoration. Photo by Gaetano Alfano

After this consolidation work on the painting ground layers, the previous grouting materials, unsuitable and incompatible with the original materials, were mechanically removed. The brick support was restored in correspondence with the through-hole of the kitchen and the large grouting was subsequently treated with a sub-level approach. The painting-level grouting was mimetically reintegrated while all the abrasions, lacunae, whitening and lack of patina were treated with lowering of tone. With an overall chromatic balance, the painting is once again legible, lively in the colours, fully showing the compositional rhythm and the refined pictorial taste of the workshop of the artists working in Palazzo Gallo (Fig. 11).
