The Role of Photogrammetry in the Conservation Management of Al Mahatta Museum, Sharjah, UAE

Ahmad Badr Aldin Fattal¹, Rami Al-Ruzouq², Eslam Nofal^{1,3}

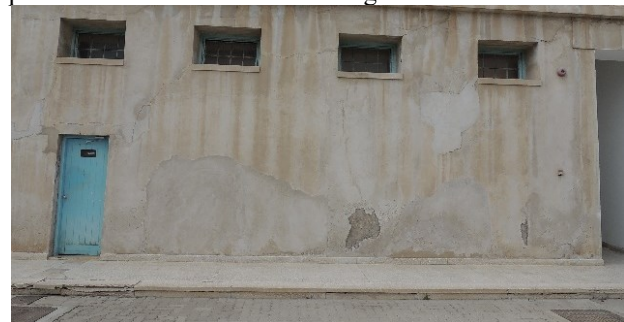
Fig. 2. Material loss in one of the museum's internal facades.

Al Mahatta Museum faces various risks and challenges, requiring a robust conservation management plan. The museum is exposed to environmental factors such as material decay and humidity, as shown in Fig. 2 and Fig. 3. Such factors may cause deterioration of the site structure over time, as shown in Fig. 4. A comprehensive and effective conservation management strategy is required to mitigate these risks and ensure the long-term preservation of the cultural heritage within the museum.

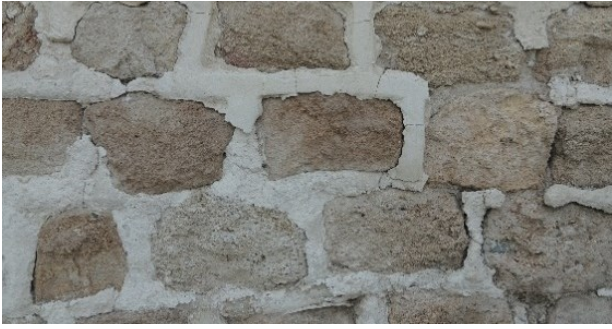
Fig. 3. Material loss in one of the museum's external facades.

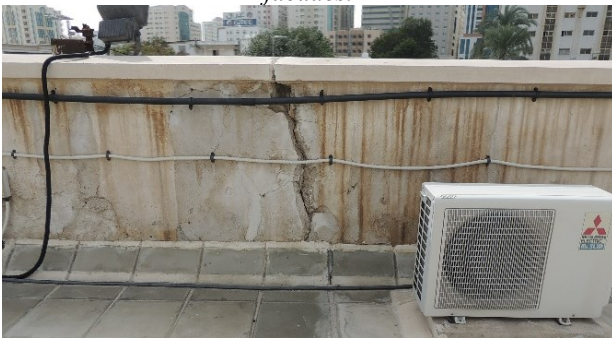
Fig. 4. Material deterioration of the museum structure as shown on the rooftop.

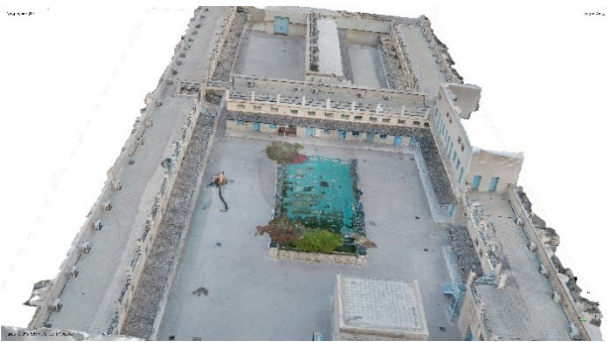
Fig. 7. Part of the generated 3D Model for the site of Al Mahatta Museum.

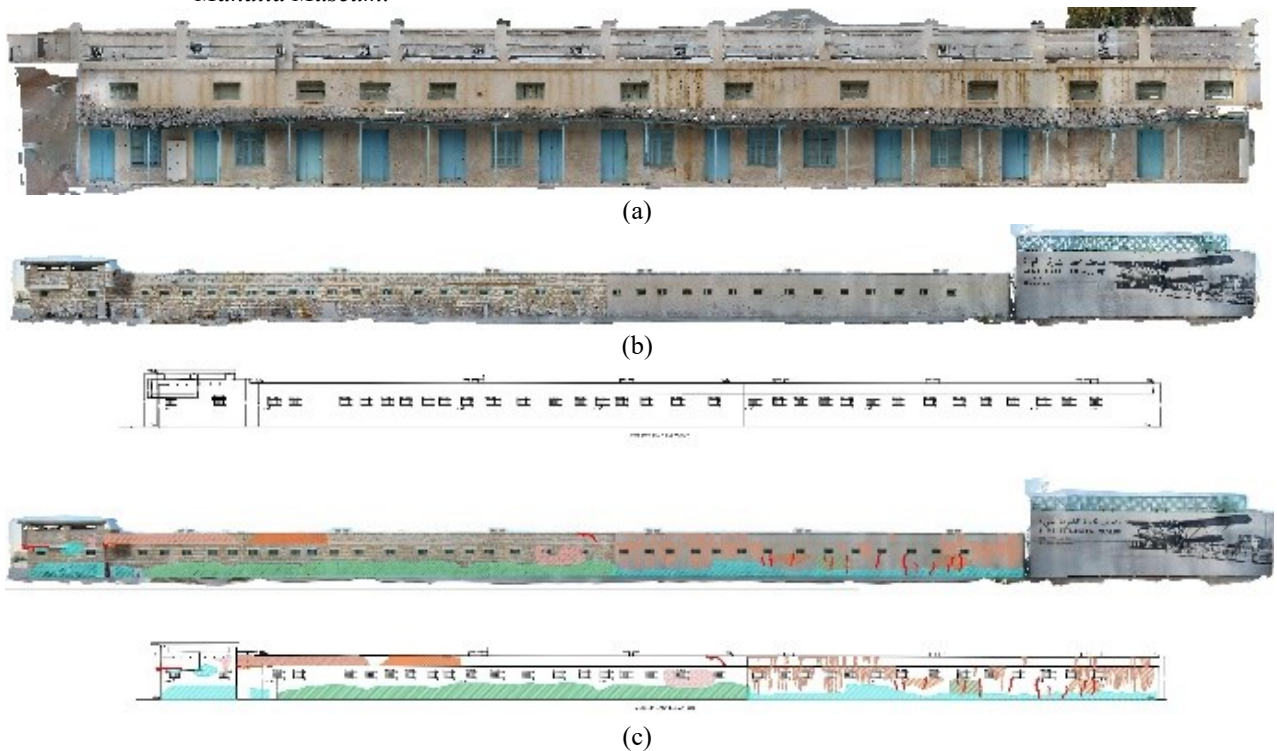
Fig. 8. The ortho-mosaic images obtained from photogrammetry (a: an example of the internal site facades; b: an example of the external site facades, c: damage assessment)

The early results obtained from photogrammetry, which have been processed in CAD software, are used in assessing the damage and material mapping to identify the state of conservation and factors affecting the site, as well as for protection, management, and monitoring, as illustrated in Fig. 8.c. In this way, decay extension and intensity can be measured with high precision and with a high level of detail, for a correct time and costs estimation of each conservation step. Furthermore, the early photogrammetry results, which have been uploaded to different platforms like Sketchfab, might facilitate accessibility and interpretation of information among different stakeholders.
