# Study and restoration of the *Sacra Conversazione* by Lorenzo Berrettini and experimental tests to evaluate the application of diammonium phosphate as consolidant for the wall painting

**Abstract** – This paper reports the study and restoration of a 17<sup>th</sup> century wall painting attributed to the artist Lorenzo Berrettini and located in a chapel of Palazzo Orsini at Bomarzo, a little town close to Viterbo, in central Italy. The wall painting was recently restored as activity of a master thesis in conservation and restoration of the cultural heritage and on that occasion the artwork was investigated to characterize the materials and techniques with the aim at choosing the best consolidation procedure and products. To reach this goal, multispectral imaging and X-ray fluorescence spectroscopy were applied on-site. After this non-invasive analysis, some laboratory investigation was performed by Fourier transform infrared spectroscopy. The results of the diagnostic campaign were used to plan the experimental tests for consolidation by diammonium phosphate dibasic (DAP) that is a relatively new product in the field of restoration of wall painting. The tests demonstrated the go

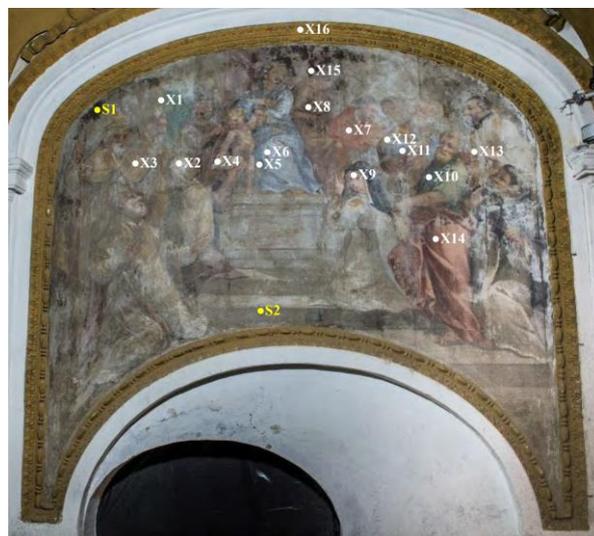
Fig. 2. Photograph of the wall painting with the points of XRF analysis (X1-X16) and with the sampling points S1 and S2.

X-ray fluorescence spectroscopy (XRF) was performed on sixteenth points (X1-X16, Fig. 2) of the wall painting through a portable instrument, Assing Surface II Monitor, equipped with Ag anode operating at 40 kV and 76  $\mu$ A.

Fourier transform infrared spectroscopy was focused on two micro-samples (S1-S2, Fig. 2) gathered from points that were selected on the base of the preliminary imaging and XRF analysis. FTIR spectra were obtained by a Thermo Nicolet Avatar 360 spectrophotometer operating

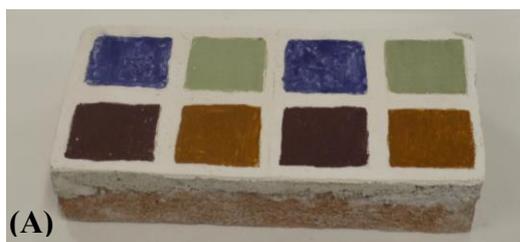
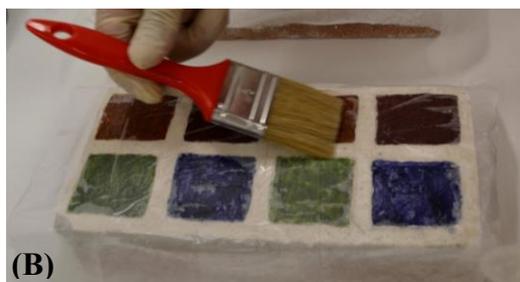
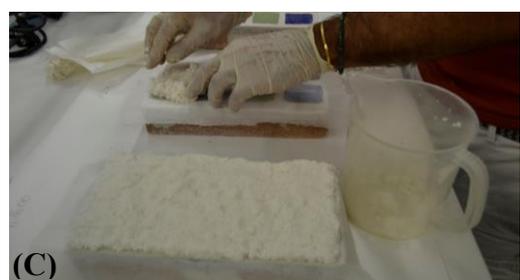
Fig. 3. (A) One of the mock-ups at the end of the preparation; (B) application of NanoRestore®, and (C) application of DAP.

For the experimental test, six mock-ups (four used for testing the consolidant products and two as control) were prepared as follows: clay bricks (14x25x3.5  $\text{cm}^3$ ) were used as support, on which a layer of arriccio was applied having as composition an aggregate/binder ratio of 3 to 1 (one part of lime paste, one part of sand, two parts grey pozzolan). A plaster layer made of lime paste (one part) and sand (two parts) was applied on the arriccio. Finally, a thin layer of finishing plaster (the so-called *intonachino*) was superimposed to the previous one. The finishing plaster was made of lime paste (one part) and marble dust (two parts). Four pigments were chosen to be applied by fresco technique on the finishing plaster layer, according to the results obtained by the XRF analysis: smalt, *morellone*, green earth and yellow Sienna. Pigments were supplied by Zecchi (Florence, Italy). Eight frescoes areas (4x4  $\text{cm}^2$ , two for each pigment) were made on each mock-up. Before applying the consolidant products, a maturation period of 30 days was elapsed (Fig. 3).

Specifically, the nano-lime, in form of dispersion in isopropyl alcohol, was applied by brush on two mock-ups without dilution and left curing for seven days. DAP was prepared in water solution at 15% (w/v) concentration and applied on other two mock-ups by means of Arbocell BC1000 paper pulp (50 g) compress, interposing a sheet of Japanese paper with a weight of 9g/m<sup>2</sup>. The DAP solution (about 150 ml) was applied with a contact time of 48h. After the application, as recommended by the technical data sheet, the mock-ups were covered by a transparent film, useful to reduce the evaporation of the water. To evaluate the performance of the products, colour measurements, peeling test and contact sponge method were applied.

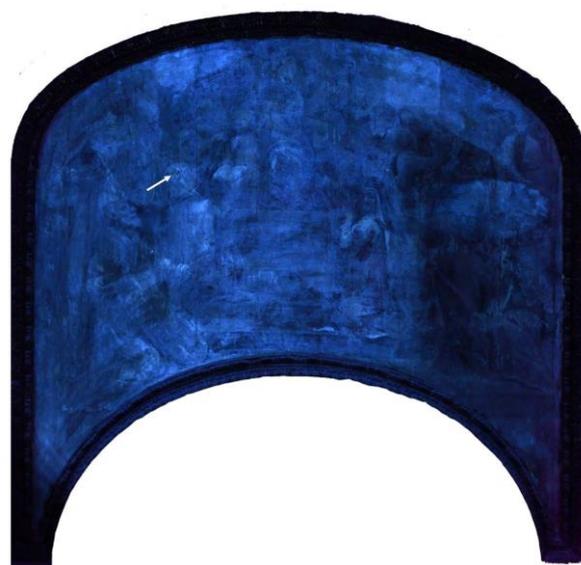
Fig. 4. UVF image of the painting before the restoration.

The first step of the diagnostics approach was to evaluate and discuss the UVF image of the wall painting shown in the Fig. 4.

The fluorescence induced by ultraviolet radiation highlights a diversified and complex situation of the painted surface, indicative of the non-homogeneous presence of variously fluorescent materials of different nature (such as, for example, animal glue applied during previous restoration, saline efflorescence, and pictorial retouching) combined with various levels of intensity in the responses attributable to the difference in thicknesses and degrees of aging of the materials present.

The photographic images of the UV fluorescence highlight a strong cold tone response variously distributed on the painted surface, due to the application of an organic resin used as a fixative of the pictorial film. Furthermore, it is possible to follow the differential degradation suffered by this material over time as the degree of intensity of the fluorescence is directly proportional to the thickness of the layer and is null where the protective appears completely removed by some previously applied cleaning tests, as well-visible in the right part of the painting. In a little zone, indicated by the white arrow in the Fig. 4, a spot of lemon-yellow fluorescence has been detected that could be hypothesised due to zinc white. XRF analysis confirmed this hypothesis (see Table 1, point X2).
