Acoustic characteristics and defects of adhesion of ancient construction materials using the PICUS system

Francesca Mariani¹, Giosuè Caliano², Stefano De Angeli¹, Paola Pogliani¹

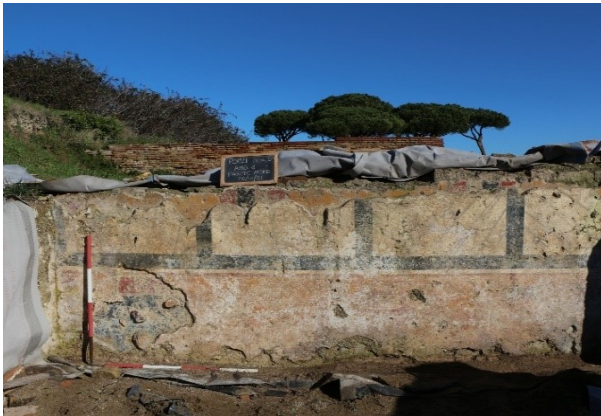
Fig. 1: In this palimpsest, a Roman wall painting decoration consists of multiple layers, including two phases of painted plaster. The visible losses in the artwork are a direct result of detachments that have occurred between these layers.

Acknowledgement: The mockup in Fig. 1 is courtesy of P. Calicchia from the Institute of Marine Engineering, Research Unit Acoustics and Sensors "O.M. Corbino", Rome, Italy.

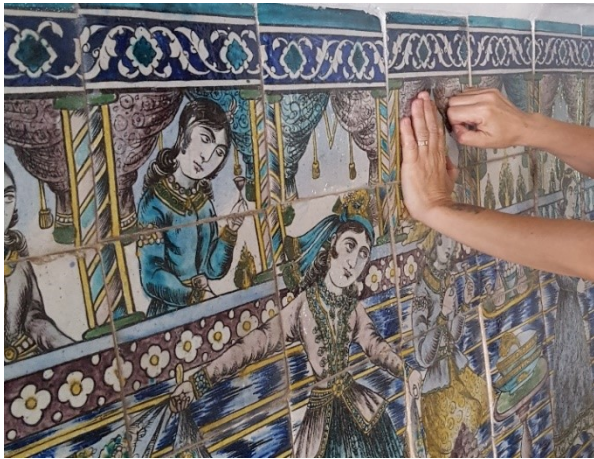
Fig. 3: A Qajar glazed ceramic panel. The distribution of the detachments is evaluated using traditional auscultation technique.

However, the application of NDE techniques in the investigation of historical and artistic heritage faces certain limitations. Conducting measurements on-site is not always feasible due to various factors. These factors indeed introduce practical challenges and cost implications, leading to the less frequent use of advanced survey techniques in practical work environments. In such cases, conservator-restorers often rely on traditional auscultation techniques to analyze detachments. This specialized, handmade procedure involves lightly tapping the surface with the fingertips or knuckles of one hand and feeling the resulting vibrations with the palm of the other hand, as shown in Fig. 3.

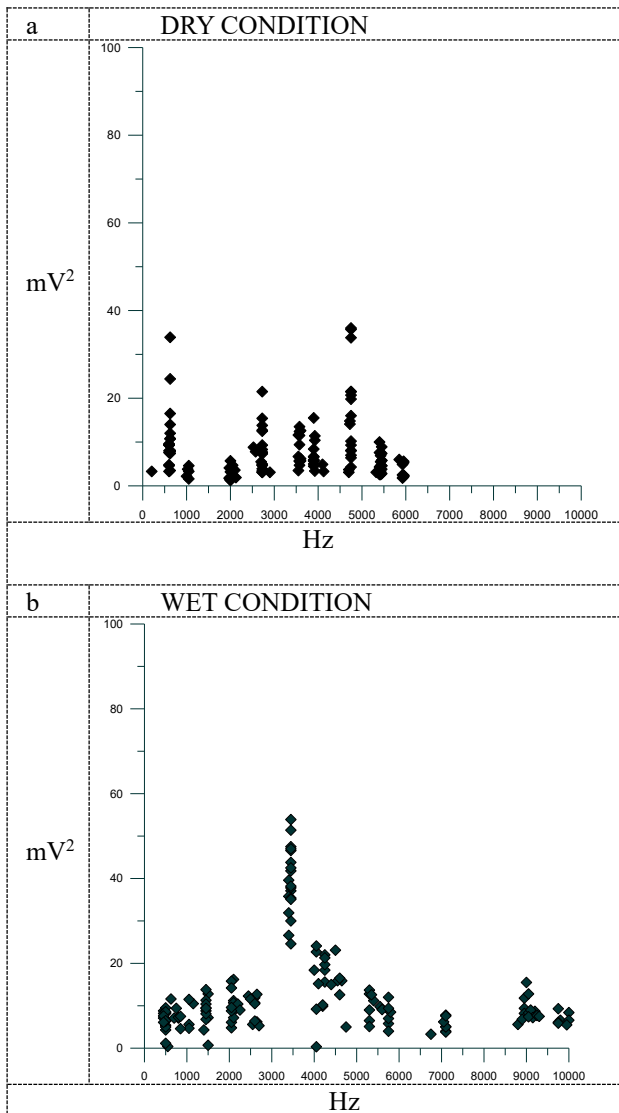
Fig. 6: a- the soundness of a dry brick; b- in the same portion of brick, now waterlogged, the power spectrum shows a different distribution, with a characteristic timbre at 3400 Hz.

The Power Spectrum graphs that follow in Fig. 6 illustrate the difference between the acoustic response of the dry brick and that of the wet brick (higher density), based on the frequencies emitted during percussion, with magnitude measured in mV² and a frequency range

varying from 0 to 10 kHz. In the wet support, a characteristic spectral component of the overall timbre map resulting from scanning the surface using the PICUS cross-correlation procedure, overlaying the base to determine the threshold at which cross-correlation index similarity can be considered. at 3400 Hz is present, which can also be discerned by the human ear.
