Frauds in the Measurement of Natural Gas

Kazuto Kawakita, Rui Gomez Teixeira de Almeida
IPT-Instituto de Pesquisas Tecnológicas
Av. Prof. Almeida Prado 532
05508-901 São Paulo / SP BRAZIL
Phone: 55 (11) 3767.4756 - E-mail: kawakita@ipt.br, ruigta@ipt.br

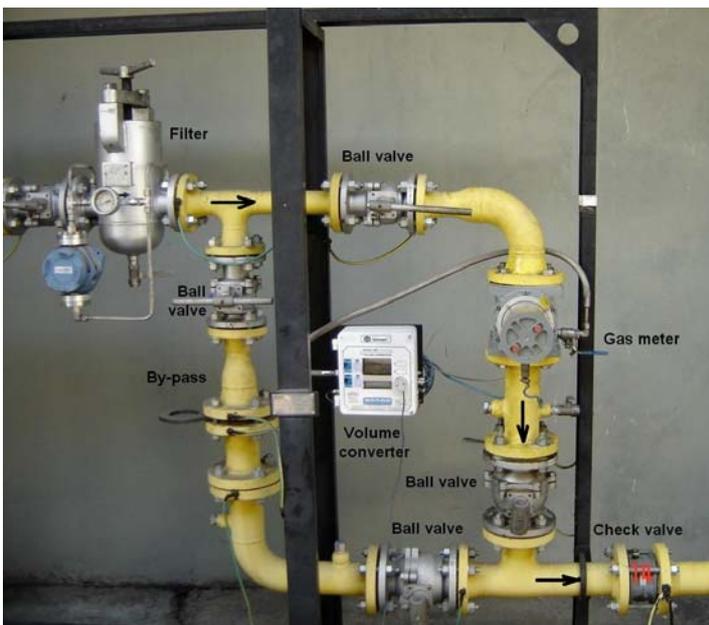
Fig. 1 A gas measurement system

Different types of gas meters and metering systems are used in the Brazilian natural gas industry. However, in the case of the measurement of the natural gas supplied to the CNG stations, due to some specific characteristics of the operating process, the gas distributor uses a system based on a rotary positive displacement meter assembled in a skid with a filter and a set of valves associated to a volume converter connected to temperature and pressure sensors. Figure 1 shows a picture of a typical gas measurement system with a rotary meter and identifies its main components.

The rotary meter is based on a rotary positive displacement metering principle in which a fixed volume of gas is imprisoned upstream and released downstream at each complete revolution of the rotors and this is defined as the cyclic volume of the meter.

This movement enters a gear train that reduces its velocity, and is transmitted to the outside part of the meter case through a magnetic coupling to minimize the risks of gas leakage. In the outside of the meter case a totalizer is connected to the transmission shaft that registers the total amount of gas that passed through the meter.

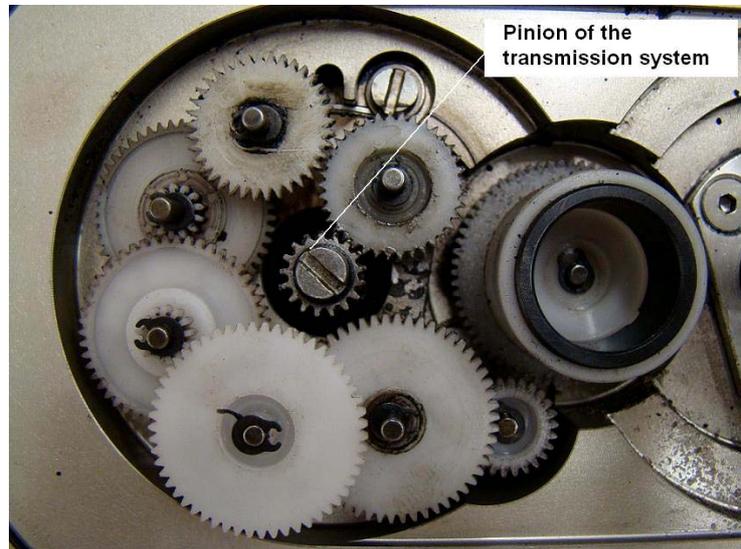
Fig. 2 Gear train and the pinion of the transmission system

Examining the gear train and comparing it with one from a new meter of the same manufacturer and model, it was detected that the meter pinion had only 17 teeth. In the original meter, the same gear has 19 teeth. Figure 2 shows the gear train and the pinion location.

Due to this strange behaviour, after excluding some hypothesis, such as possible problems in the gaps or in the volumetric chambers of the meter, it was decided to open the meter and verify the transmission system.

Frauds involving changing the gears of the meter can be difficult to be detected only by an analysis of the consumption data, mainly if the difference is set in a lower value, for instance minus 10 %. That also can be hard to be detected in inspections or calibrations since the fraud can be undone when the defrauder receives a notification from the gas company advising him that there will be an inspection or a maintenance service in the metering station, since such a procedure is required according to the Brazilian regulations.

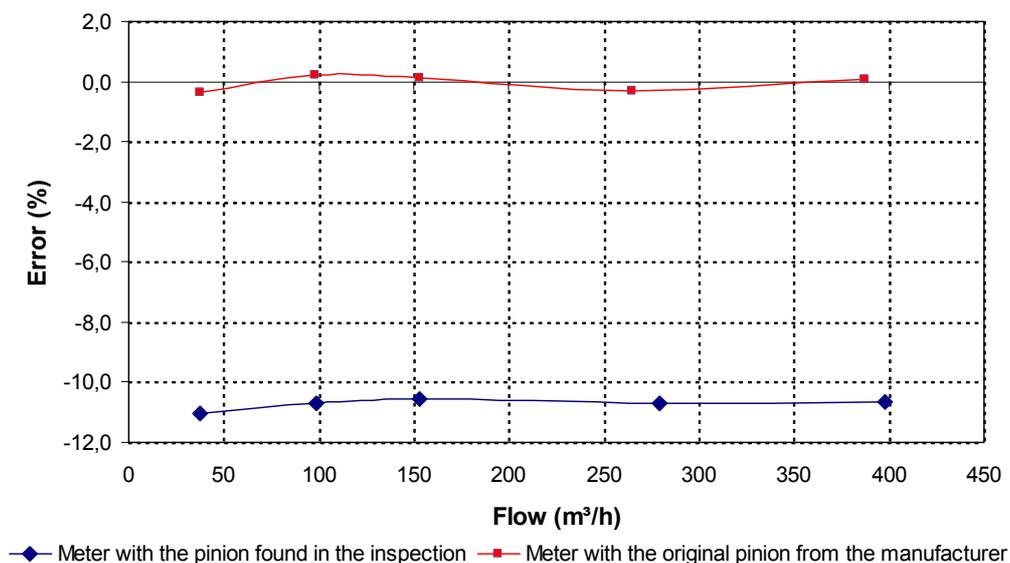
Fig. 3 Calibration results for one and the other pinion

Analyzing the results obtained in the calibration, it was noticed that the indication error was of approximately -10 % in all calibrated flow range. The result was considered very unusual considering this type of meter. According to the practical experience it is known that if a gas meter presents an operating problem, it usually presents variable errors in different flow rates and particularly this error tends to be more negative in the lower operating range.

Just to certify that this was the only factor of the detected problem, the 17 teeth pinion was replaced by an original 19 teeth pinion and the meter was calibrated again. The results were very good with a typical error curve close to zero. Figure 3 shows the calibration results of the gas meter using both pinions for comparison.

Several other similar cases were found with the same kind of fraud using different gears and, some times, a combination of different gears. In these cases, the mean errors detected varied from -5 % to -45 %.

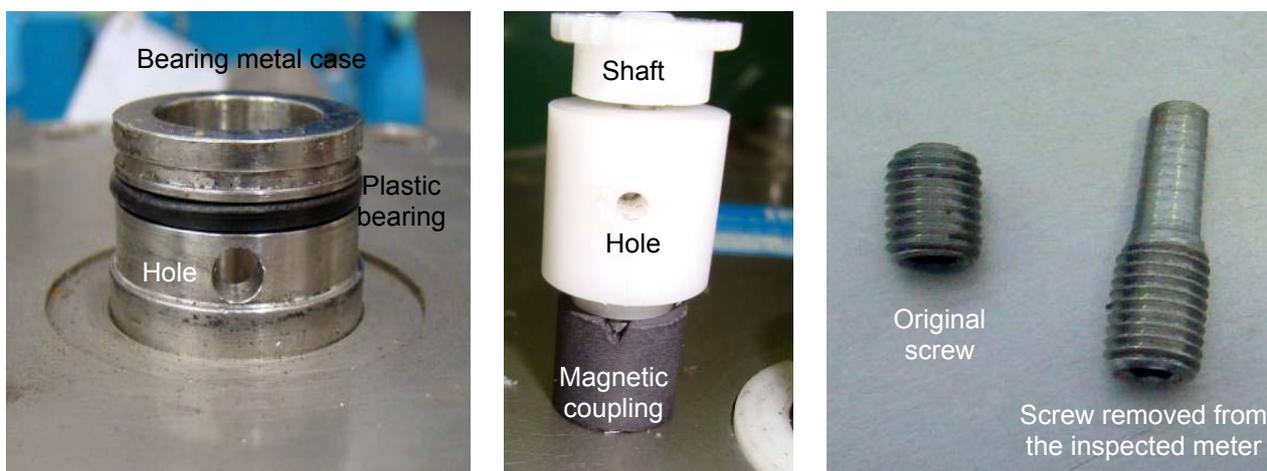
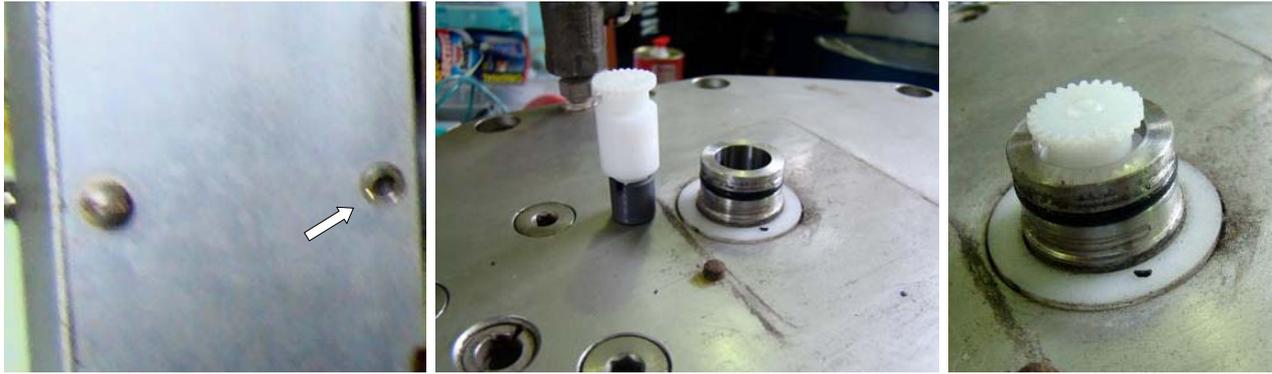
Fig. 4 A set of pictures of the modified parts separately and the of the pieces mounted

In the inspection it was detected a small machined hole that was made in the outside of the bearing metal case and in the plastic bearing were the shaft (that drives the movement for the totalizer) and the magnetic coupling are installed. These internal holes were aligned with each other and with a thread hole that is part of the meter original project. This hole, in the original meter, is where a small screw is attached to make pressure on the metal case to prevent the totalizer body to rotate, once it is set in a fixed position. Removing this screw and forcing a toll into the holes it is possible to reach the transmission shaft. Then, by applying a small force in the toll, it is possible to avoid the shaft from turning because, as the coupling is magnetic, it does not transmit much torque and the shaft stops moving without breaking any part of the meter. Removing the tool and passing gas, the meter returns to work normally.

In other fraud cases identified based on the same principle it was found a screw that had identical characteristics of the original screw in the end part that appears to the outside of the meter. However, it had a needle in the other extremity and when the screw is completely squeezed, it makes contact with the shaft and the totalizer stops moving. On the other hand, if you release the screw a little bit, the totalizer returns to operate normally.

Figure 4 presents a set of pictures of the modified parts separately and also of the pieces assembled.

a) Bearing metal case and hole

b) Plastic bearing with the hole, shaft and magnetic coupling

c) Original screw

d) Place in the bottom of the totalizer where the screw is fixed

e) The pieces to be assembled

f) The all set assembled

The fraud described in item 3.2 can also be difficult to detect based just on a consumption data analysis. It can be detected only by means of a careful inspection of the internal parts of the meter. So, the meter can go through a laboratory calibration and even a basic maintenance involving cleaning and adjusting and the fraud may still remain undetected. Another problem is that this fraud can be carried out even without breaking the meter seals and does not need to stop the gas supply and the risks are smaller than the previous one. However, once made, the fraud can not be undone.

- More care is being taken in the sealing process of the meter and the metering system. In some cases it was found that there was a lack of seals in certain points (that should be sealed) or a badly sealing process had made easier the access to the meter. After these analyses the process of sealing was improved and even some other sealing points were added.

- A special lockable metallic case to protect the meter and the volume converter and another hard plastic casing attached to the meter was developed to make it harder to access these equipment and to make it easier to observe any external drilling that could be made in them.
