## EXPERIMENTAL STUDY OF TILE GROUT MATERIAL BEHAVIOR

**Summary:** Study provides preliminary results of experimental study of tile grout material behavior. Experiments were performed with the use of microCT, three point bending test and methods for chemical analysis. It was proven that material behave very elastic and the suitability of the combination of used methods.

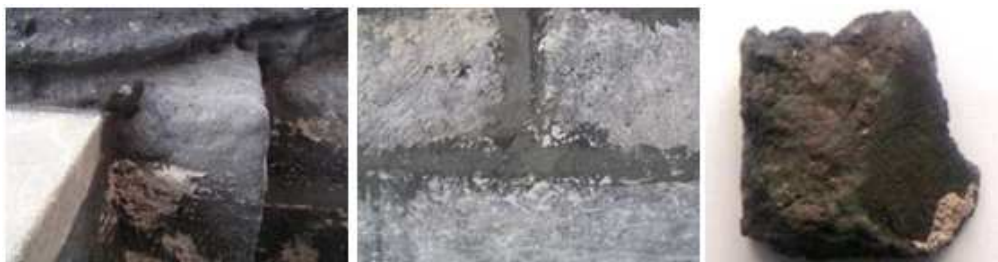
Experiments were performed with a specimen of the tile grout with dimensions 22 x 24 x 40 mm. Specimen was taken at the gallery on the south facade of the tower, where wind erosion, abrasion and typical loss of the original relief structures are particularly reflected. Place of collection of the sample is shown in figure 1(a), (b), the sample itself in figure 1(c). The whole specimen was scanned by X-ray microtomography.

Figure 1: Specimen - (a) Place of collection, (b) gaps appearance, (c) sample.

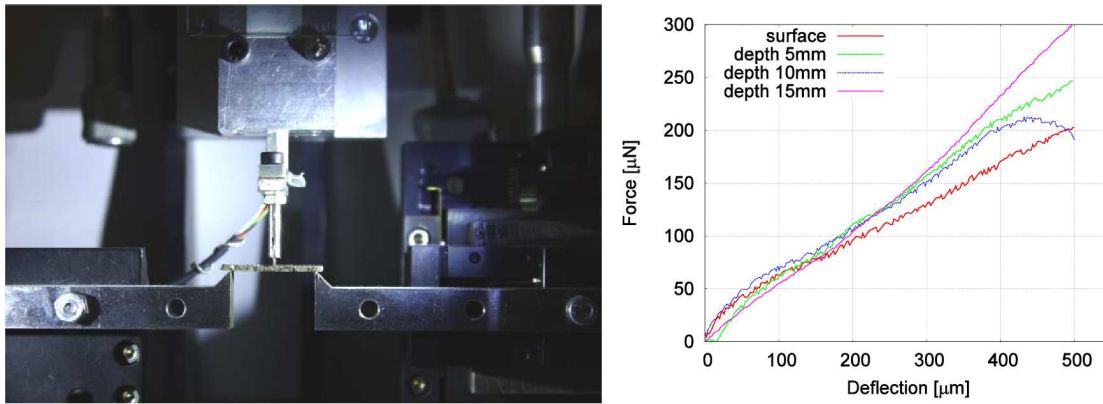
Three point bending test was carried out employing custom developed experimental setup for micromechanical testing. Detail of the setup with the sample is depicted in figure 2(a). Micrometric screws allow repeatability of the measurements in range of micron. Based on real time controlling software module both displacement and load driven experiments could be performed. Set of samples obtained from different level of the bulk material was tested in displacement controlled mode. Span of the supports was set to 20 mm, cross section area of the sample was approximately  $1.5 \times 2.6$  mm. Maximal deflection of the samples was set to 500  $\mu$ m. Euler-Bernoulli beam theory was used for calculation of elastic properties of the samples. Graph of the load test is plotted in figure 2(b).

Figure 2: Three point bending test - (a) experimental setup, (b) graph of force versus displacement.

From three point bending test modulus of elasticity was calculated. Summary of results is presented in table 1. Values increases with respect to the distance from the surface.

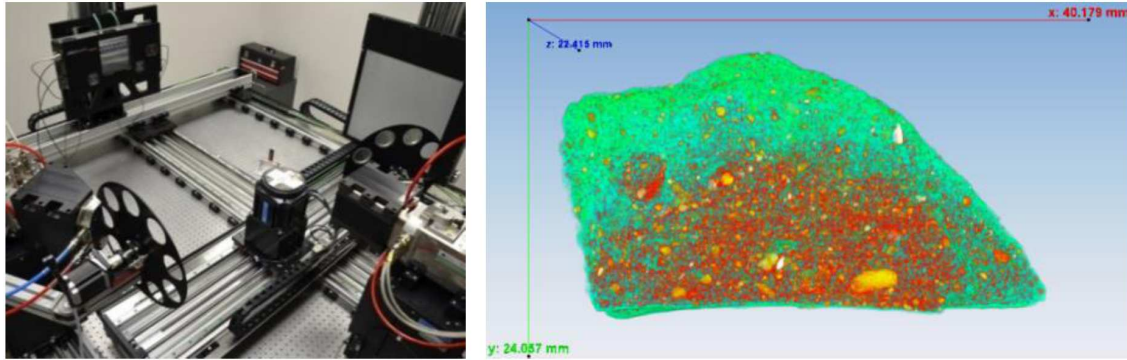
Tile grout specimen was tomographically analyzed using in-house developed system for X-ray microtomography (see figure 3(a)). X-ray tube XWT-240-SE was operated at target voltage 120 kV and target current 180  $\mu$ A. Flat panel detector Perkin Elmer XRD 1622 AP 14 with active area 400x400 mm and pixel pitch 200  $\mu$ m (2048 x 2048 pix) served as X-ray imager. Radiograms with acquisition time 2x1 sec were acquired during 800 projections with angular step  $0.45^\circ$  for computed tomography (CT) reconstruction purpose. Beam hardening correction was applied on all radiograms. CT reconstruction was done using cone beam recon-

struction algorithm implemented in the Voxel 6 software. In a reconstructed volume, one voxel represents a cube with edge length  $25.2 \mu\text{m}$  due to projective magnification (given by the relation between distances tube-sample/tube-detector). The reconstructed 3D microstructure of the tile grout is imaged in figure 3(b).

Figure 3: X-ray microtomography - (a) experimental setup, (b) 3D visualisation

Visualization of tomographic volume data in figure 3(b) shows different composition of the material caused by weathering. In the depth (top) grout was protected against climatic influences, but on the surface (bottom) occurs the loss of light small particles and large ones are therefore very visible and more represented.

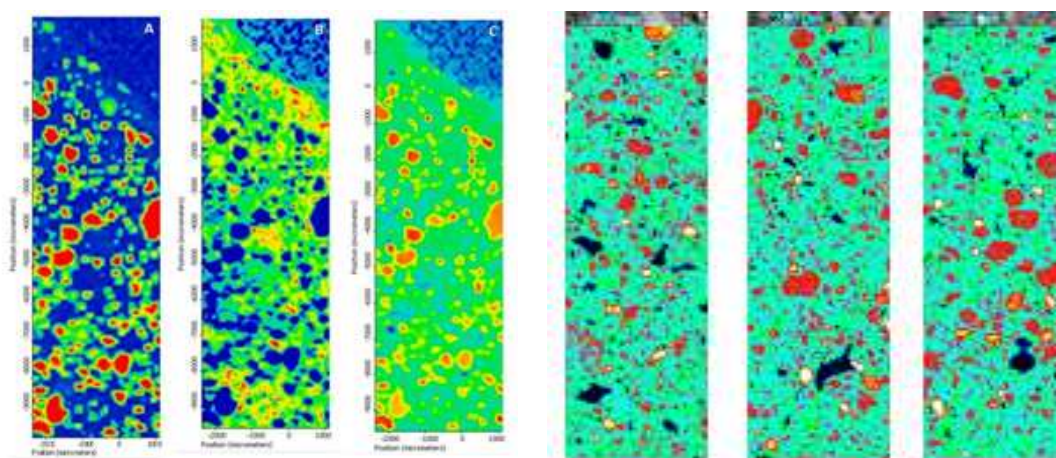
Obtained chemical maps of the sample are depicted in figure 4(a). The distribution of quartz, calcite and the organic phase is well distinguished. Big grains in the pointing mortar are formed by quartz. Calcite is present around these grains as the final product of carbonation reaction. Organic phase as well as calcite is well distributed in areas between aggregates. The occurrence of the specific analyte in maps is depicted by different color: in red are represented the areas with the highest concentration and in blue the absence of each phase.

In figure 4(b) comparative microtomography slices are captured in the same scale. Local color distribution of materials corresponds to results of chemical analysis. Moreover microtomography has in this case much better resolution and contrast.

Figure 4: Maps - (a) Chemical maps: A - quartz, B - organic phase, C - distribution of matrix around quartz grains; (b) Material maps of the sample acquired by microCT.
