Diagnostics of a hydraulic turbine failure

Abstract – This paper presents the failure analysis and diagnostic of a hydraulic turbine. Shortly after a maintenance revision the thrust bearing of the turbine was destroyed when the turbine was put into operation. The damaged bearing was examined and the possible causes discussed. To identify the problem that led to the failure of the thrust bearing, a comprehensive on-site measurement campaign was done. Vibrations, pressures, temperatures and operating parameters were acquired at different operating conditions of the turbine. The analysis of the data allowed to determine the source of the problem and to implement a solution.

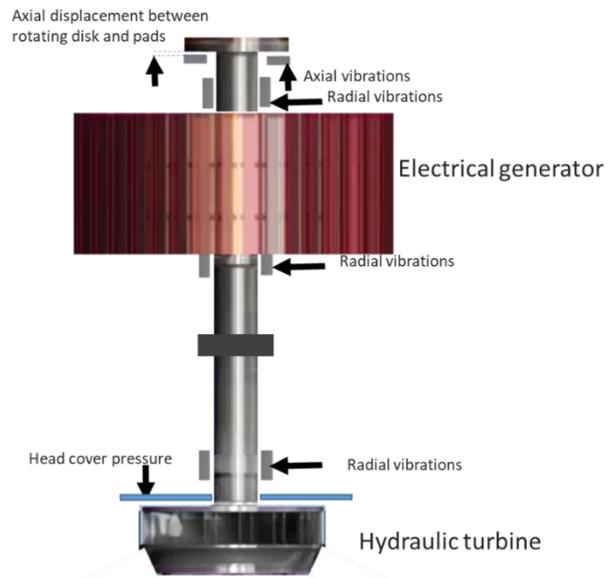
In Figure 4, the measuring locations in the Francis turbine are shown. For the measurement, a multichannel acquisition system B&K with accelerometers, proximity probes and pressure sensors was used. In addition, the operating parameters (power, rotating speed, etc.) and temperatures were recorded from the Scada software of the power plant, as well as the axial displacement of the shaft related to the thrust bearing pedestal.

Fig. 4. Measuring positions during the tests
