Advanced condition monitoring of Pelton turbines

Abstract – The ability of hydropower to adapt the electricity generation to the demand is necessary to integrate wind and solar energy to the grid. Nowadays hydropower turbines are required to work under harsher operating conditions and an advanced condition monitoring to detect damage is crucial. In this paper an improved method for condition monitoring procedure of Pelton turbines is introduced.

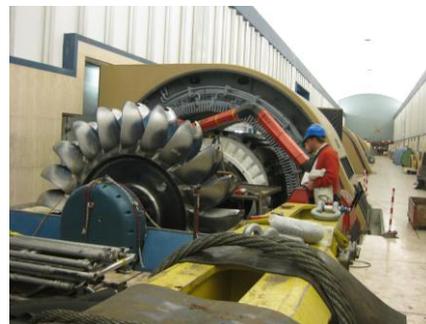
Fig. 1. Pelton turbine open for inspection

A Pelton wheel consists of a disk to which a series of buckets are forged along its edge. During operation the buckets receive the impact of the water jets, thus being subjected to strong pulsating forces that lead to large structural deformations. These deformations give rise to stresses that, after a long time of operation, may break the wheel because of fatigue. In order to prevent the wheel from breakage, a periodic surveillance of the machine is mandatory. In Figure 1 a picture of a horizontal shaft Pelton turbine open for inspection is shown.

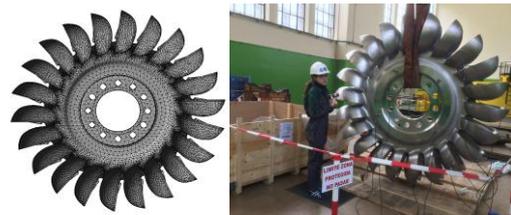
Fig. 3. Wheel model and experimental validation

The first step consisted in obtaining a numerical model that resembled the existing machine and could be able to simulate its dynamic behavior. For this purpose, a model was created by means of FEM and was later compared to the real machine. In Figure 3 the numerical model of a Pelton wheel and the real wheel during experimental tests are shown.
