Image Analysis Techniques for the Detection of Defects at BGA by X-Ray

This paper deals with the development of image analysis for the detection of defects at BGA solder joints in PC boards by using X-ray imaging. We can't detect visually defects at BGA solder joints, because they are hidden under the IC package. To improve a cost performance and the reliability of PC boards, an inspection of BGA is required in the surface mount process. Types of defects at BGA solder joints are solder bridge, missing connection, solder voids, open connection and miss-registration of parts. As we can find mostly solder bridge in these defects, we pick up this to detect solder bridge in a production line. The problems of image analysis for the detection of defects at BGA solder joints are the detection accuracy and image processing time according to a line speed of production. To get design data for the development of the inspection system, which can be used easily in the surface mount process, it is important to develop image analysis techniques based on X-ray image data. At the first step of our study, we attempt to measure the shape of BGA based on X-ray imaging.

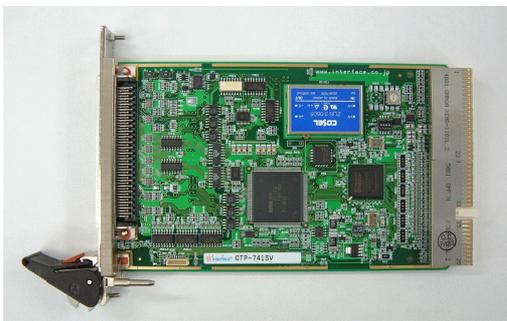
Fig.1 Photograph of one example of test board.

In the most case of defects at BGA solder joint, the solder bridges between two balls are founded in a production line. This defect results from excess solder or misplaced solder, since dirty solder paste stencils are often founded in a production line. In manufacturing PC boards, IC package used with BGA is CPU for main function in an electronics circuit. In the actual production line, we can find the test IC packages based on the final electrical circuit test. Fig.1 shows a photograph of one example of a test IC board. The thickness of PC board is 2 mm and it has six layers. IC package is mounted with BGA to the surface of the PC board. The solder ball diameter is 0.76 mm and the ball pitch is 1.27 mm and the number of BGA is two hundred and fifty six. The size of IC package is 27x27 mm. This test package does not pass the electrical function test. We consider this package has defects at BGA solder joints.

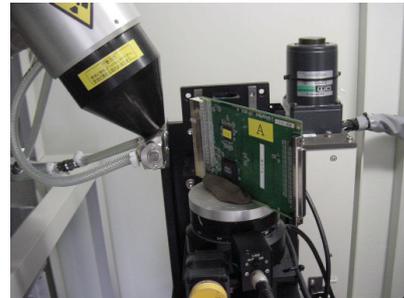
Fig.2 Apparatus for capturing X-ray images.

rotated the test table from 0 degree to ± 50 degrees on every 10 degrees as shown in Fig.2. By rotating the test package, we can take X-ray image with inclined penetration and attempt to detect BGA bridges from different direction. When the angle of inclination is over 50 degrees, we can't distinguish each solder ball, because of overlapping of images. The condition for capturing image data is as follows. X-ray tube voltage: 185 KV, X-ray tube current: 160mA, exposure times: 30 seconds.

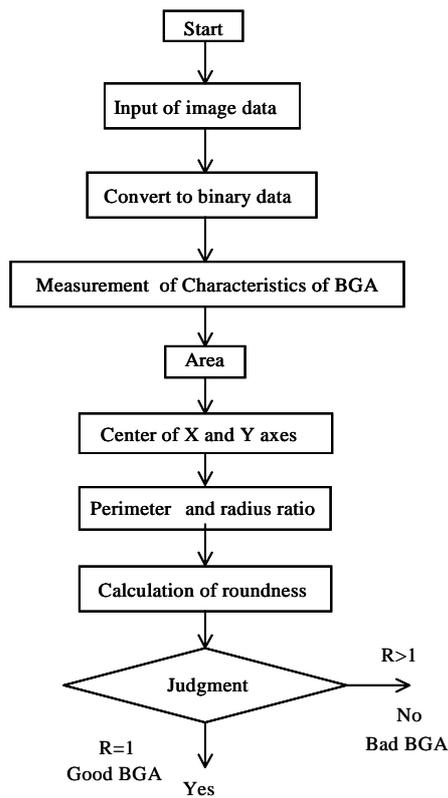
Fig.3 Flowchart of image analysis.

Fig.3 shows a flowchart of an image processing for X-ray image data obtained by the above apparatus. Image data is an input data to the personal computer for analysis. Image is converted to the binary data to detect accurately the counter of a solder ball. Threshold level is determined based on signal profile on horizontal line. We selected 54 count gray levels as the threshold level and converted to black and white image data to measure accurately the following factors of BGA. After labeling, first we measure the area of each solder ball and center of X axis and Y axis. Next we measure the perimeter and the radius ratio of each solder ball. A normal pattern of a solder ball is a circle. If a solder ball has defects such as bridge, the shape of the object separate from a true circle. In the case of solder bridges, two solder balls are shorted with the narrow path and we can observe the different pattern such as connected with the bridge.

In order to judge whether the solder joints are connected normally to the base pad in a surface mount process or not, we pay attention to the radius ratio and the roundness of a solder ball. Roundness R is calculated by the following equation.

$$R = L^2 / 4\pi S \quad (1)$$

Where L (m) is the perimeter of a solder ball, S (m^2) is the area of a solder ball.

If the object is a true circle, the radius ratio and the roundness equal to 1. As the shape of the object separates from a true circle, the radius ratio and the roundness become larger than 1. The judgment whether BGA is good or not is determined by the radius ratio and the roundness. If the value of these terms equals to 1, we judge BGA is normal. Then, if the value of these terms overrun equal to 1, we judge BGA is abnormal.

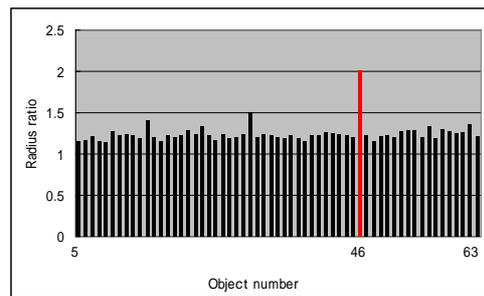
Fig.6 Radius ratio.

Fig.4 shows an example of the original image data series captured by the above apparatus with inclined penetration of X-ray (inclination angle:-10 degrees). In this picture, we can observe one abnormal BGA. We analyzed this image data based on the above method. Fig.5 shows the binary image data after labeling. Fig.6 shows the radius ratio of each solder ball and Fig.7 shows the roundness. In order to analyze accurately the radius ratio and the roundness of a solder ball, we checked the image size of the solder ball. Then, we selected the diameter of a solder ball is 20 pixels. The roundness is one for the true circle by equation (1). The actual radius ratio and the roundness of a solder ball is a little over one as shown in Table 1. This table shows an example of the result of the image analysis.

When the radius ratio is below 1.5 and the roundness is below

1.1, we judge BGA is normal and if two terms overrun these values, we judge BGA is abnormal. In this table, we can find one abnormal solder ball as shown in the data number 46. The radius ratio is over 1.5 and the roundness is over 1.2, namely, 2.01436 and 1.20937 respectively. Therefore, we can warn this solder ball is abnormal. This abnormal image data is shown as number 46 in Fig.5. This test package is inspected in the function test of the electrical circuit and determined as an abnormal board. Except only one or two solder balls, we can't find another abnormal point in this test board. In the X-ray image, we could not find obviously two balls short but can find a ball having tail.

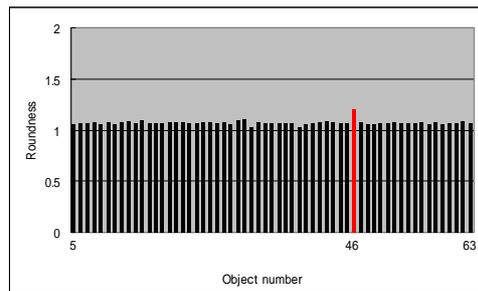
Fig.7 Roundness.
